## **POLISH-EGYPTIAN RESTORATION MISSION AT KOM EL-DIKKA, ALEXANDRIA, 1992-93**

**Wojciech Kołataj**

In accordance with a long-term program approved by the Egyptian Antiquities Organization, the Polish-Egyptian Restoration Mission continued work in the Theater, Bath and Cisterns from October 1992 to May 1993.<sup>1</sup>

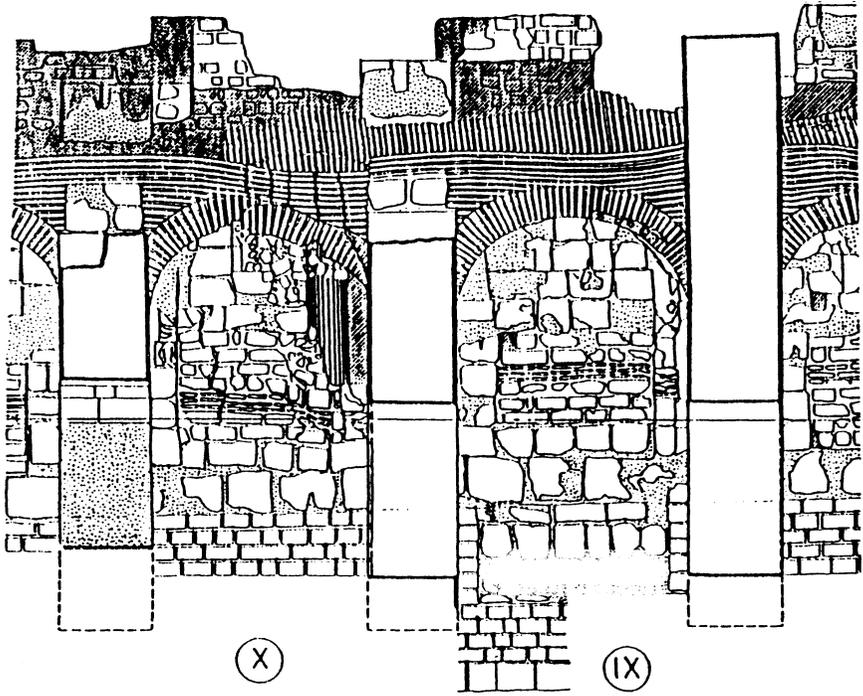
Following the consolidation of the unit X arcade in the theater corridor, that is, ambulatory, the central segment was explored, removing the fill deposited after the edifice had been abandoned in the 7th century. The adjacent section of the outer wall, which also sustained heavy damage during modern construction works in 1964 before the theater was discovered, also called for immediate consolidation (Fig. 1). An inventory was made of the wall facing before the entire section was dismantled; the wall was then reassembled preserving as much of the ancient substance as could be retrieved; in many cases the original mortar in the joints was preserved, although several seriously damaged or crushed blocks had to be replaced with new ones (Fig. 2). The newly applied mortar was similar to the ancient one and composed of sand, lime, and powdered bricks with a 5% addition of white Portland cement. In the upper part of the wall, a com-

*Fig. 1. Theater. Inner face of the corridor prior to restoration.  
Drawing by the author.*

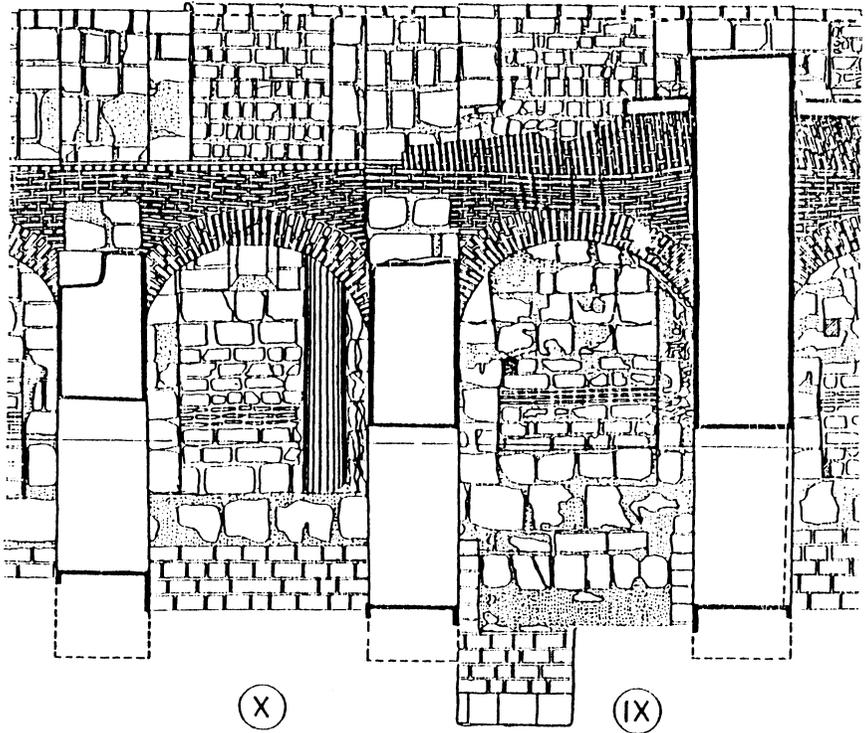
*Fig. 2. Theater. Inner face of the corridor after restoration.  
Drawing by the author.*

pletely destroyed window frame was thoroughly restored to its original shape.

A modern concrete pillar set into the wall was left in place for structural reasons as much as educational purposes

(removing the pillar could have caused serious damage to the wall, while it has already become part of the monument's history).
