# KOM EL-DIKKA

## PRESERVATION WORK, 1998/99

Wojciech Kołataj

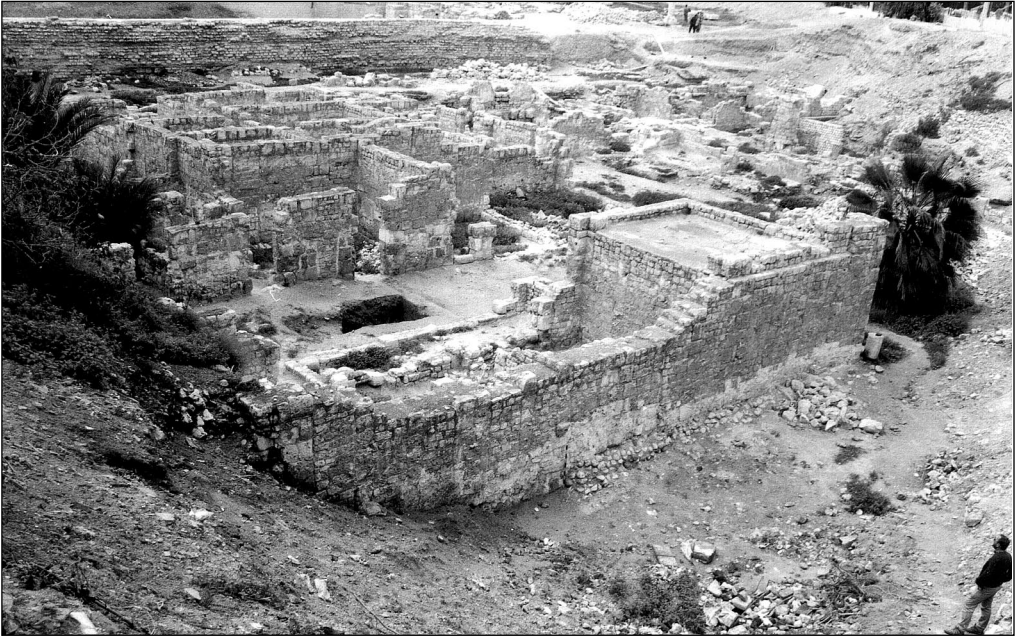
*Fig. 1. Roman residential quarter. Site of the mosaics before the construction of the shelter  
(Photo W. Kołtataj)*

The four mosaics (panels with representations of birds, a rosette, a panther and the *opus sectile* pavement) selected for this project belonged to an Early Roman villa (1st-2nd cent. AD) situated in the Roman residential quarter, in the southeastern corner of the site (close to Saphia Zaghoul street) (Fig. 1, 2). The mosaics, which display different subjects and techniques of execution, and which testify to subsequent phases of occupation, are located c. 4.5 m above sea level. They were first excavated in the 1970s, protected provisionally and covered.<sup>2)</sup> The present project entailed the conservation of the mosaics, partial rebuilding of enclosing walls, and erection of a specially designed shelter over the mosaics (15 x 12 m) complete with an access path to the building and information displays for the public.

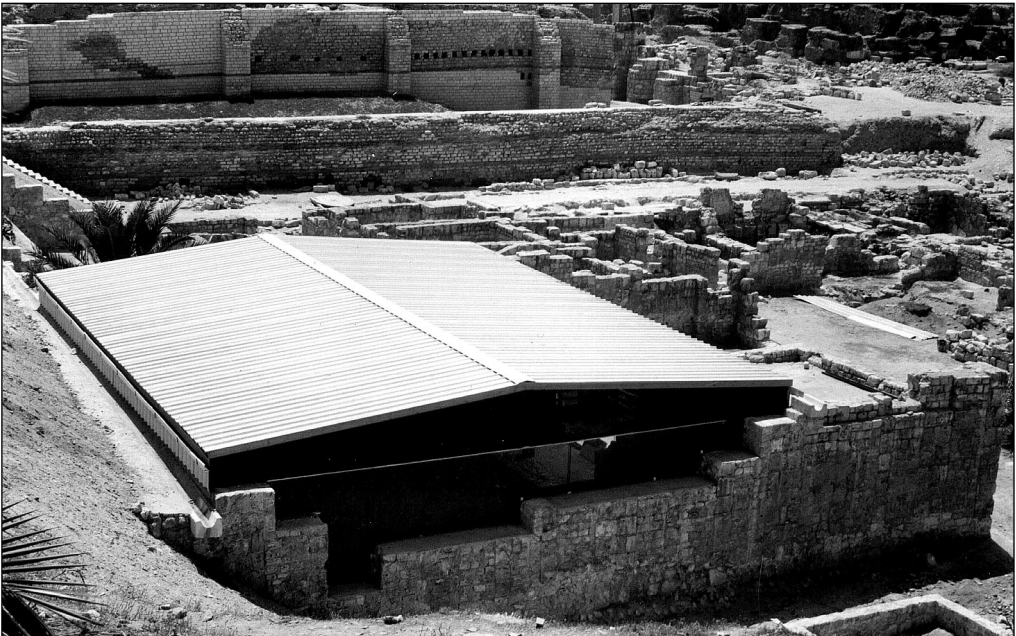
*Fig. 2. Roman residential quarter. Site of the mosaics after the construction of the shelter  
(Photo W. Kołtataj)*

The new discoveries imposed substantial changes of the original shelter design. The shelter, which had to be extended to the west and south, was designed as a kind of glass case inserted among existing walls of the Byzantine buildings B and F. The gable roof of the shelter was covered with beige-colored corrugated iron sheets, thermally insulated with styrofoam. On the south, the trusses of the gabled roof rest on a reinforced concrete beam supported by four reinforced concrete pillars (measuring 0.50 x 0.25 x 5.1 m) and on the north on pillars and a steel beam. The supporting structure is entirely hidden behind the Byzantine walls.

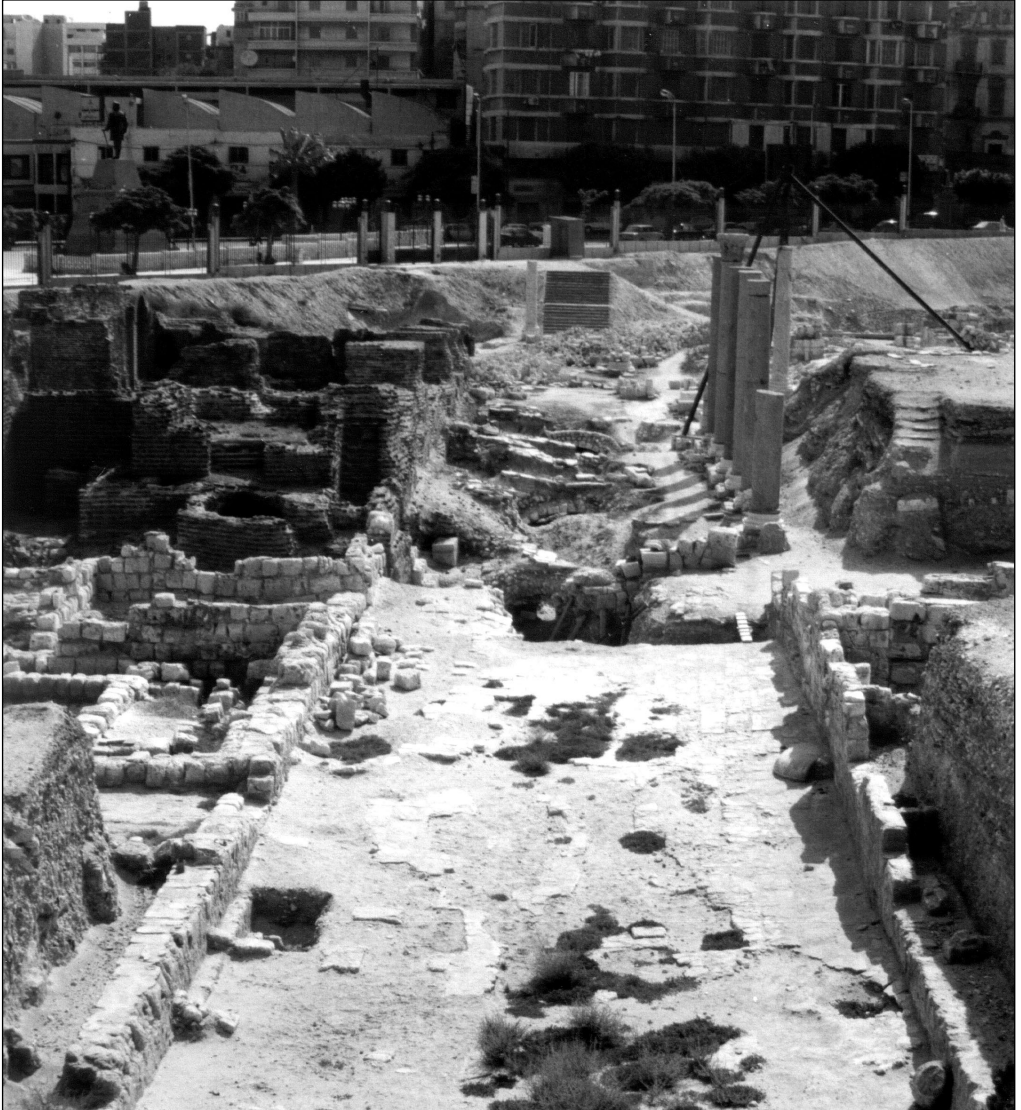
*Fig. 4. Southern passage of the baths  
(Photo W. Kolqataj)*

Landscaping operations along Saphia Zaghoul Street required new steps to be constructed from the main gate on this side to the southern passage of the baths,

which will constitute the main tourist path of the Archaeological Park to be created soon at the site (*Fig. 4*). A section of the foundation wall of the main bath entrance

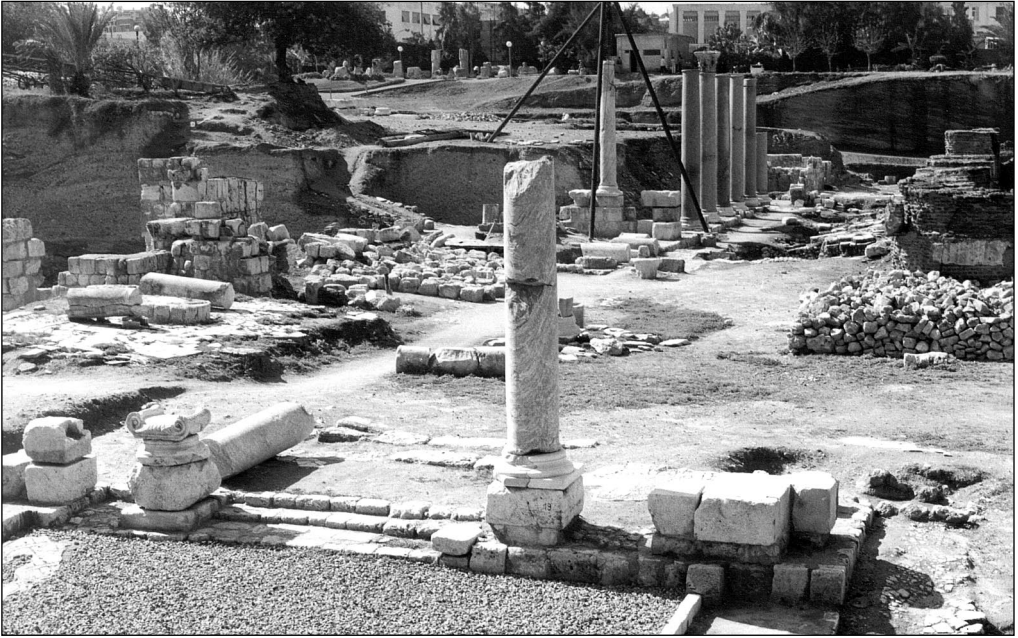
*Fig. 5. Eastern edge (entrance) to the southern passage of the baths  
(Photo W. Kołtataj)*

from street R 4 was reconstructed (*Fig. 5*). The anastylosis of a marble column at the corner of the southern gymnasium was completed (*Fig. 6*). Conservation work in the cisterns has nearly been completed. The northern facade was accorded top priority. A badly damaged and eroded fragment of the original wall (c. 15 m<sup>2</sup>) was carefully dismantled and reassembled following conservation treatment of particular blocks. The reconstruction of missing parts of the facade was also initiated. A new foundation wall was prepared along the entire facade (c. 23 m long), and several courses in the wall were restored

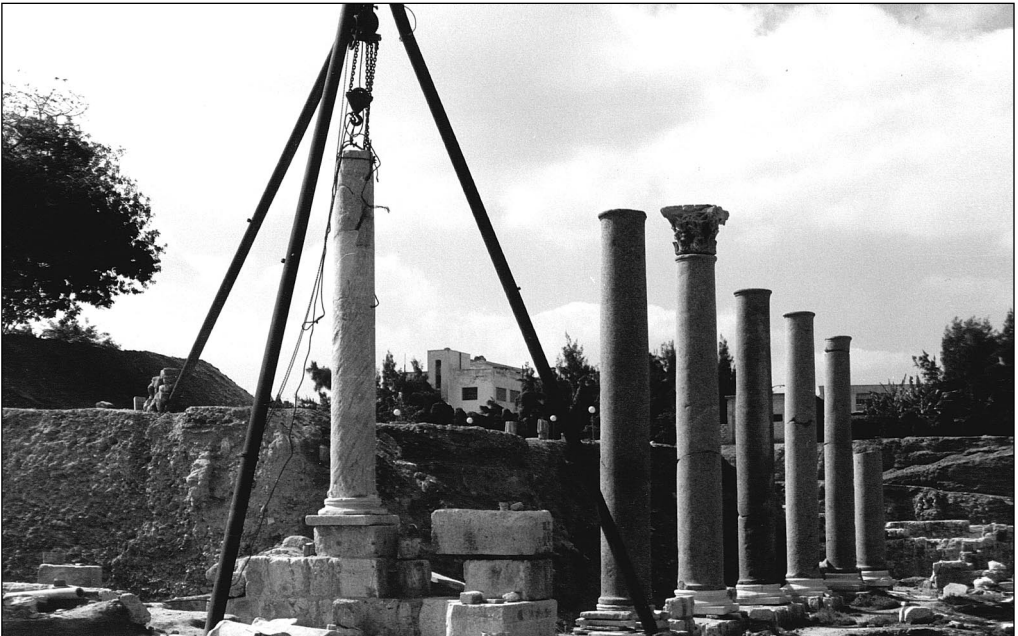
*Fig. 6. Anastylosis of a marble column from the southern gymnasium  
(Photo W. Kołtataj)*

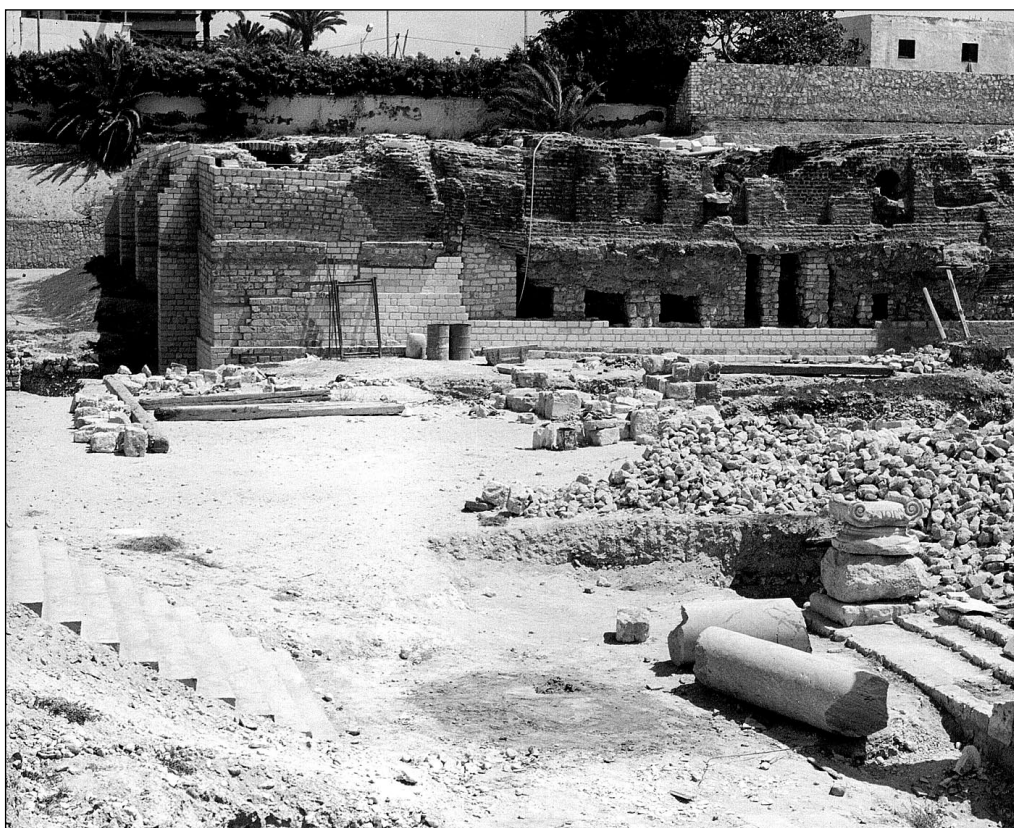
*Fig. 7. Cistern. The northern facade during reconstruction works  
(Photo W. Kołtataj)*

(c. 18 m<sup>2</sup>). Serious delays in the supply of building materials precluded the completion of some of these operations (*Fig. 7*). A long-term operation for removing c. 15,000 m<sup>3</sup> of earth and debris overlying the Theater Portico has left the area open to archaeological excavations, which have begun in the southern end. The discovery of yet another fallen column of the portico prompted the decision to execute new bases for the columns with a view to completing the planned reconstruction. In preparation for the anastylosis of the Portico in the next season, two bases were cut of Helwan limestone.
