# KOM EL-DIKKA

## PRESERVATION WORK, 2000/2001

Wojciech Kołataj

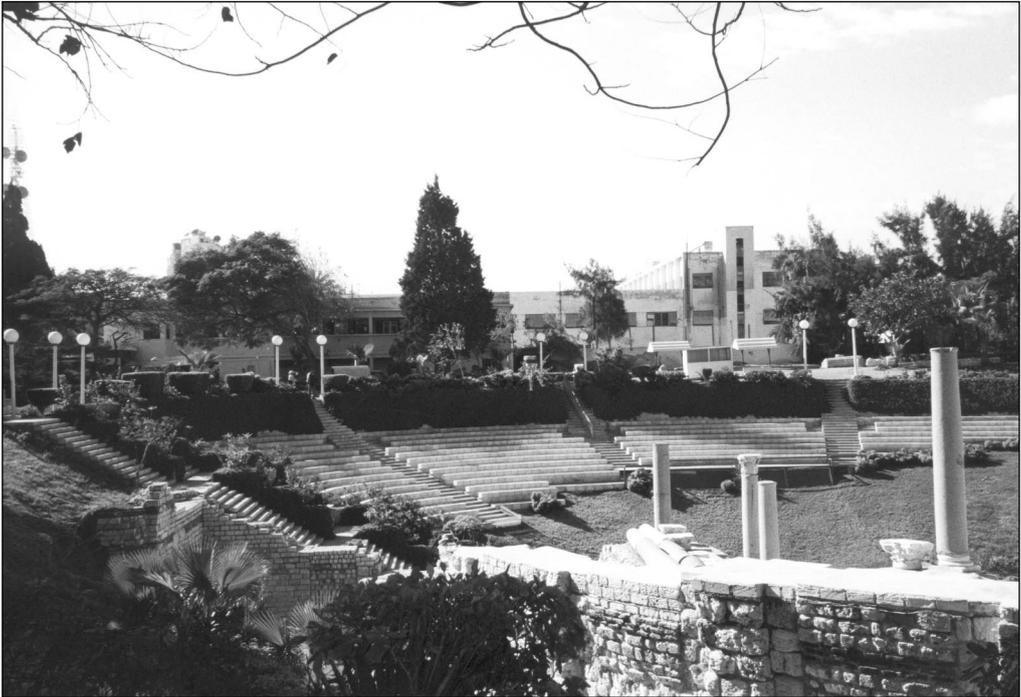
*Fig. 1. New auditorium erected west of the ruins of the ancient theatre (back wall visible in the foreground) (Photo W. Kołtątaj)*

The abrupt decision of the Egyptian authorities, in August 2000, to build a new auditorium on the slope opposite the ancient theatre on the Kom el-Dikka site came as a total surprise. Within three weeks, during the summer break in archaeological work, a big part of the stone-built auditorium was erected (*Fig. 1*), as well as a showy staircase which extends the Roman street in front of the theatre to the south. Thus, an architectural conception that I had proposed several years ago has finally been given shape (see previous reports in PAM).

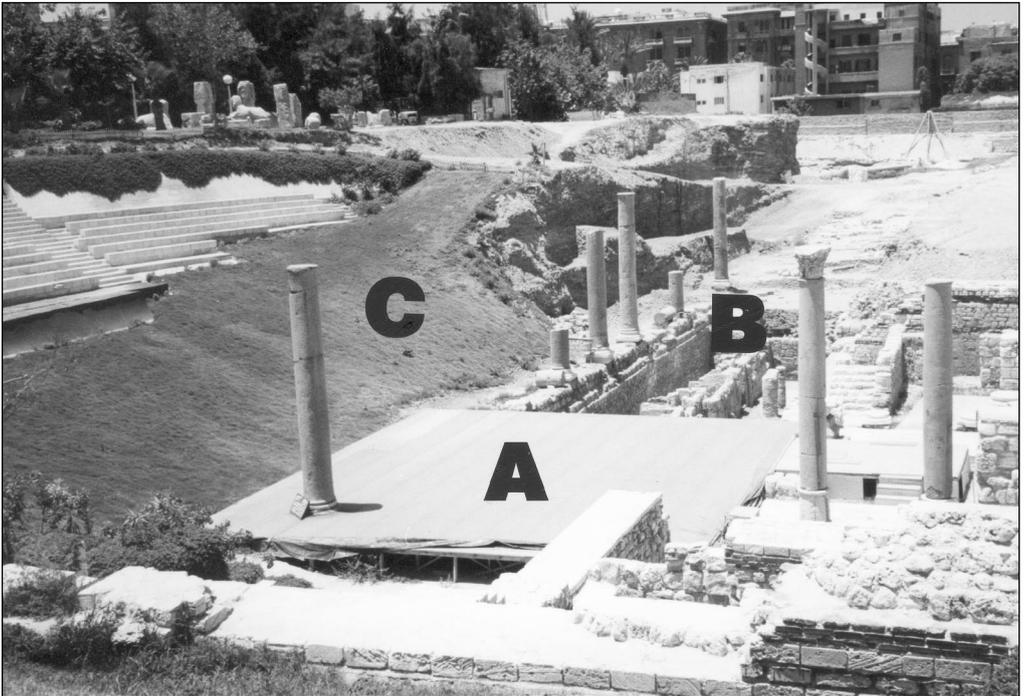
Fig. 2. Area west of the ancient theatre: A, B, C problem areas requiring a solution in the future (Photo W. Kołataj)

- How to construct the new wooden stage-platform so that it does not inter-

ferre with the tourist flow (*Fig. 2: A*)?

- How to connect the newly excavated area and the future mosaic-floors display in this area with the modern structure (*Fig. 2: B*)?
- How to extend, if at all, the new auditorium to the north (*Fig. 2: C*)?
- How to drain away rainfall water?
- Why the material used in the new structure is not of appropriate quality?

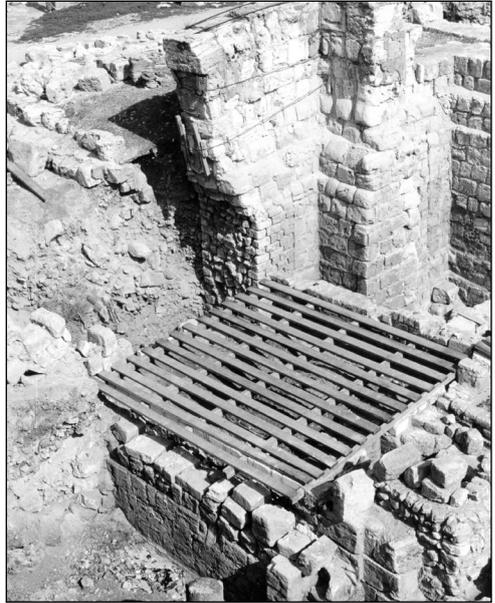
*Fig. 3. Roman baths. Western section of the southern outer wall before anastylosis (Photo W. Kotłaj)*

In the bath, the southern outer wall of the complex in the western section was completed. Major parts of this wall were reconstructed using original blocks found during excavations (Figs. 3, 4). Nearby, one of the underground vaulted chambers (probably the eastern entrance to the underground service area) was protected and partially reconstructed. The work will be finished next season once the existing part of the outer wall has been cleaned and examined archaeologically. The cellar, fitted

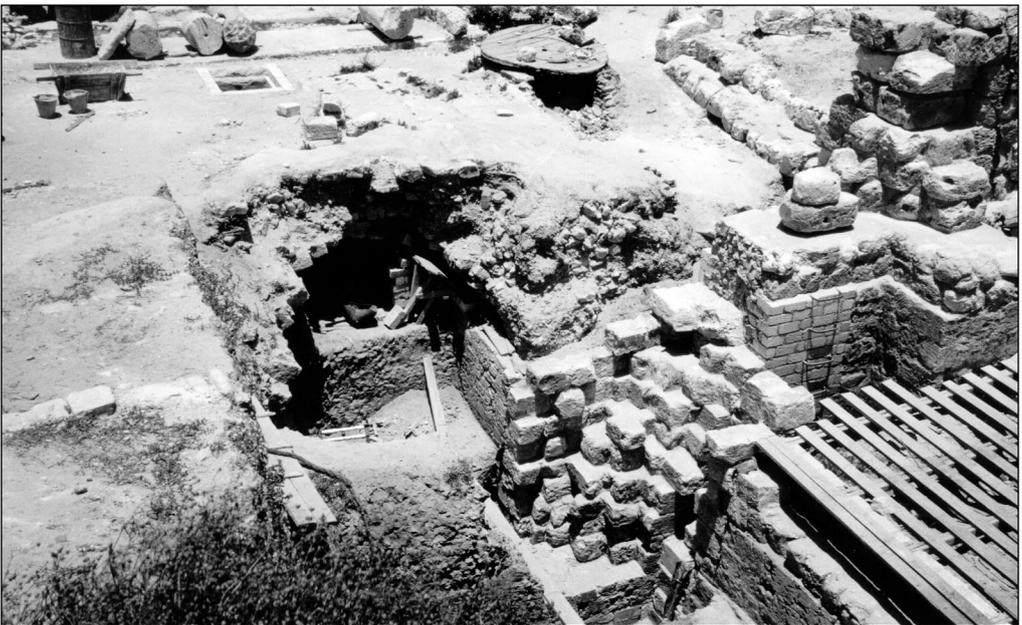
*Fig. 4. Roman baths. Western section of the southern outer wall after anastylosis (Photo W. Kotłaj)*

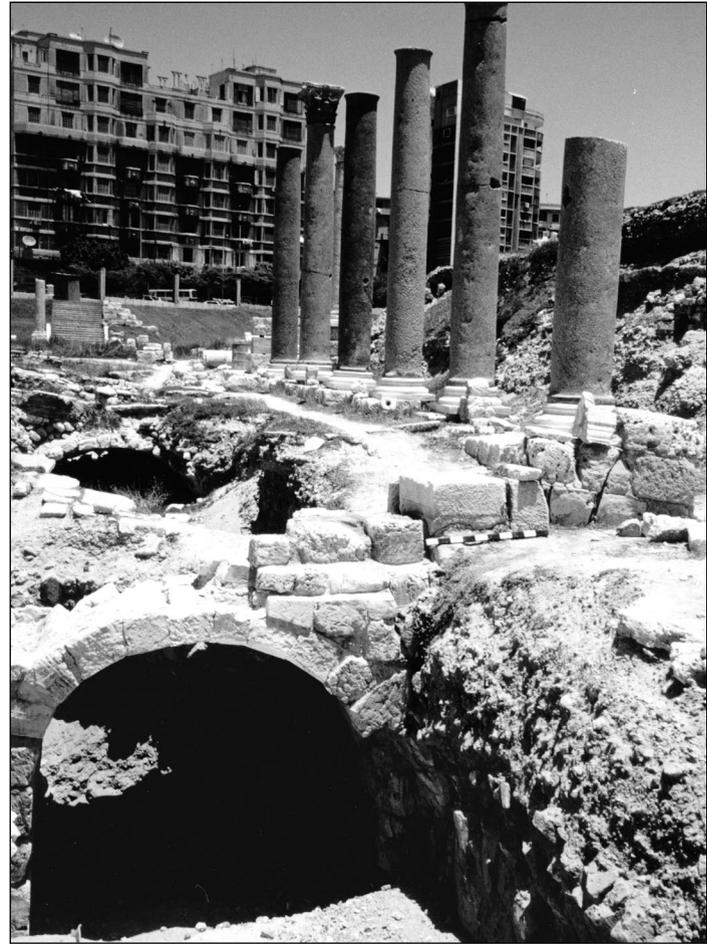
Fig. 5. Roman Baths. Gateway arch of the southern section of the underground service area corridor before (left) and after reconstruction (Photo W. Kotłaj)

In the southern section of the corridor of the underground service area, in its western part, a gateway arch was protected and partially rebuilt (Fig. 5).
