# ALEXANDRIA: EXCAVATIONS AND PRESERVATION WORK ON KOM EL-DIKKA, SEASONS 2012 AND 2013

Grzegorz Majcherek

Polish Centre of Mediterranean Archaeology, University of Warsaw

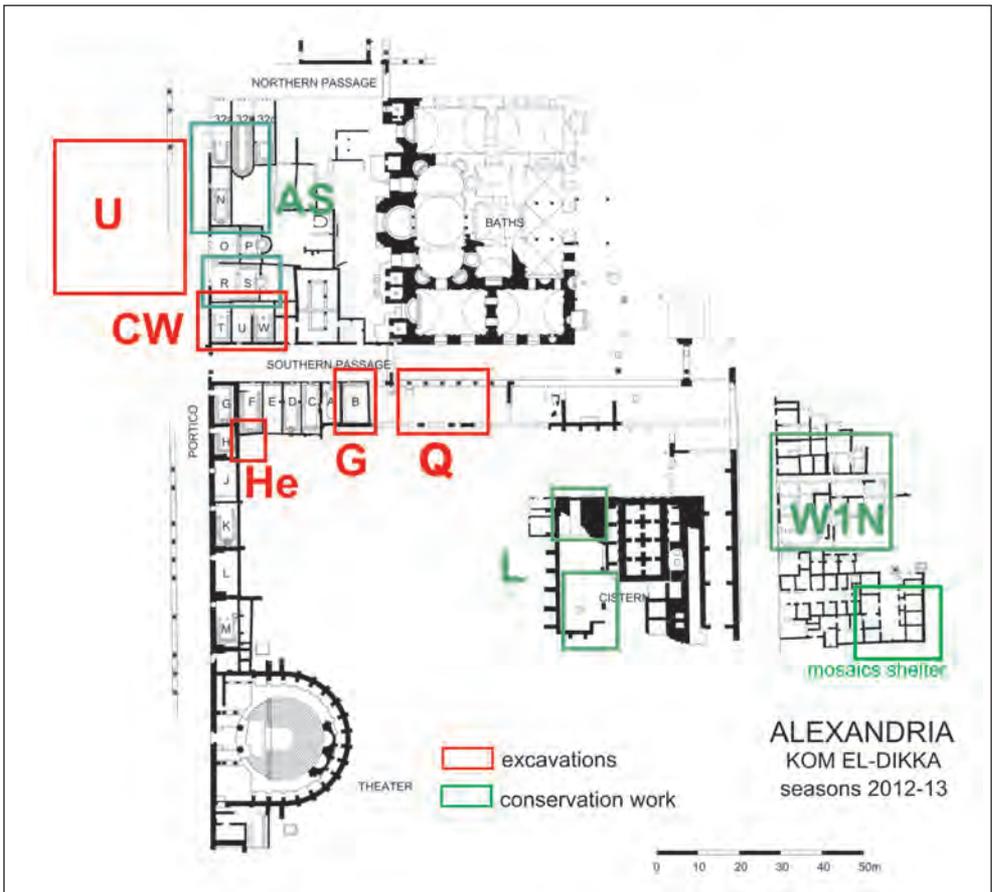
Fig. 1. Kom el-Dikka site: areas of excavation and conservation work in the 2012 and 2013 seasons (Drawing W. Kolqataj, D. Tarara)

(area L) and auditoria (area CW). The precious early Roman mosaics in the mosaic shelter (Villa of the Birds) again necessitated maintenance conservation [Fig. 1].

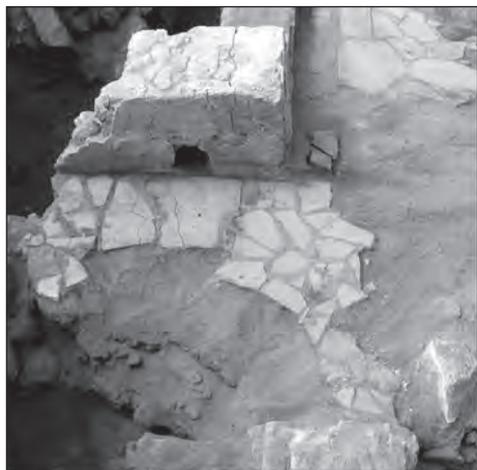
Kucharczyk 2014: 33–35) [Fig. 3 bottom]. On the western and northern sides of the channel, several patches of flooring made of assorted fragments of marble tiles were cleared [Fig. 3 top]. A fragmentary preserved section of the perpendicular wall marks the end, or rather the beginning of the channel. A small hole pierced in this wall (approximately 18 cm in diameter) at floor level was most probably used as an outlet for water spilling over the pavement, draining it into the channel. No evidence of a water supply system has been found so far. Users may have actually brought the water needed for hygienic purposes with them in vessels. The western limits of the latrine could have been marked by a huge wall, the negative of which parallels the channel at a distance of approximately 2.30 m [Fig. 4]. Remnants

Fig. 3. Latrine channel: top, northern end; bottom, looking south (Photos G. Majcherek)

Immediately below some remains of early Roman structures were cleared. They formed the end section (2.70 m long) of a sewage channel of the large *forica* discovered last season (Majcherek and

of this wall found to the north of the sewer consisted of a short, preserved section; it was 0.80 m wide and was built of large blocks exceeding, each one, 0.40 m in length. The location of the entrance and communication with other structures previously uncovered in the area remains to be determined, although the building follows the same orientation.

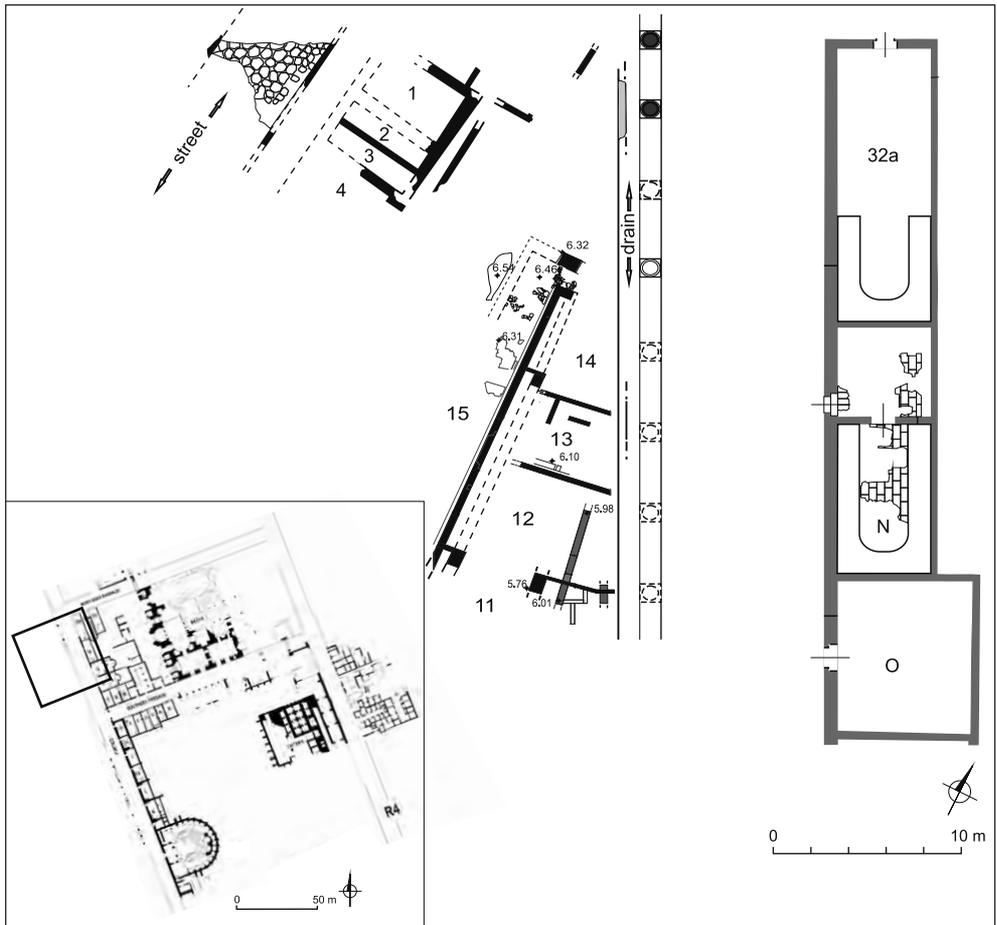
Fig. 4. Plan of early Roman structures in area US  
(Drawing M. Polak, A. Pisarzewski, G. Majcherek)

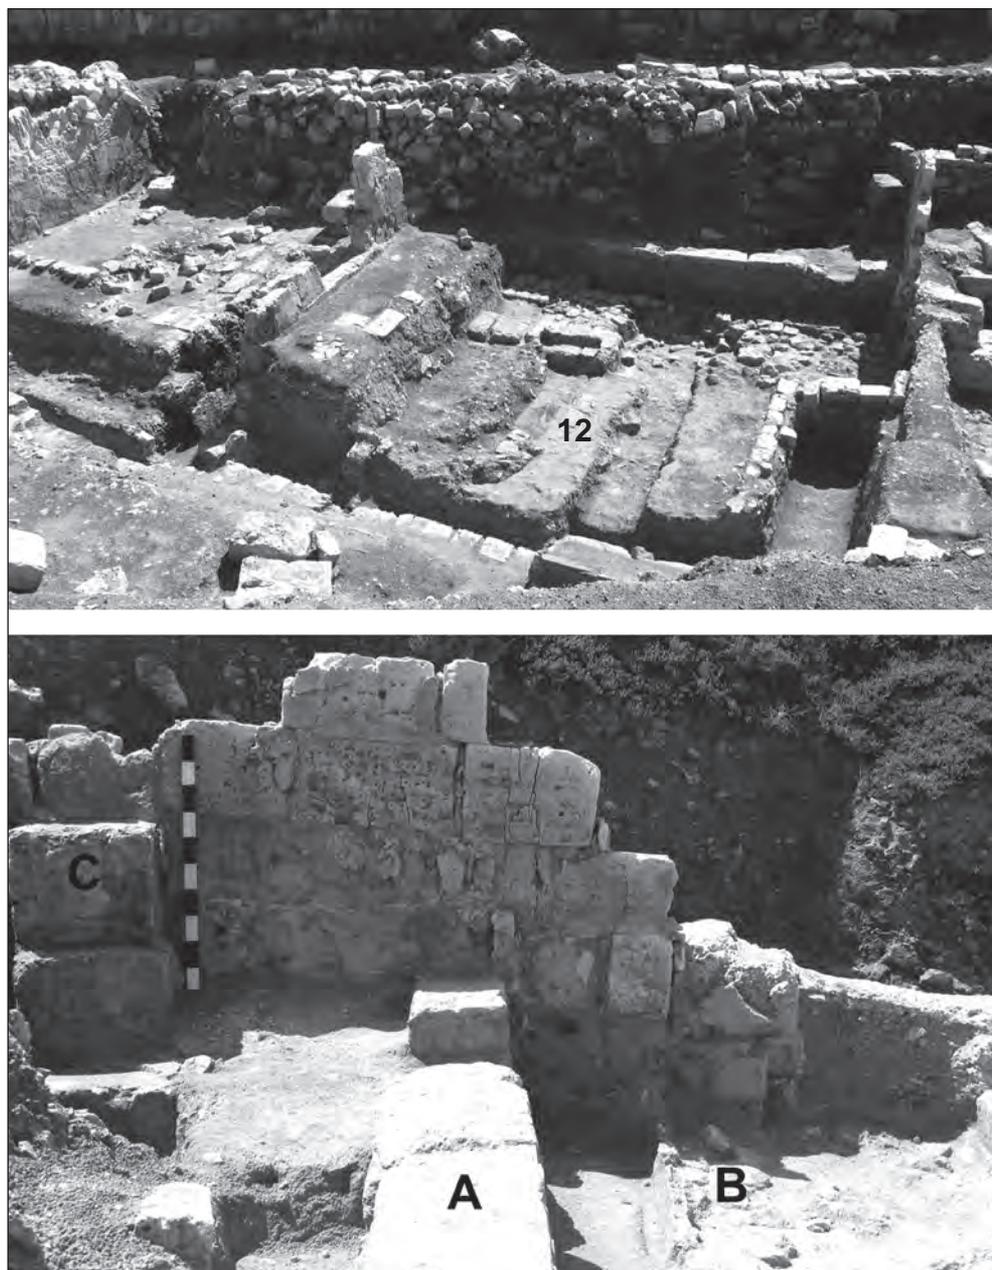
Fig. 7. Earlier structures in room 12 in area US: top, view of the remains below the floor of room 12, looking east; bottom, view looking south, A – earlier wall, B – later wall, C – wall enclosing the area from the east (Photos G. Majcherek)

In the 2013 season, the excavation was focused on the underfloor layers in room 12, in order to assess architectural development and chronology (trench supervisor Walter Wójtowicz). The results were somewhat ambiguous and disappointing however. It turned out that the area was occupied continuously at least from the late 1st century AD. Minute exploration produced a series of occupational layers that could not be dated precisely and several earlier structures which also could not be identified satisfactorily owing to a fragmentary state of preservation of the architecture [*Fig. 7 top*]. Remains of a solid wall (about 0.35–0.40 m wide) were discovered in the eastern part of the trench [*A in Fig. 7 bottom*]. Structured of large regular

masonry and retaining the plaster coating, this wall ran northward for a distance of 3.70 m; at this point it breaks off before reaching a later wall dividing units 12 and 13. It was replaced apparently by another wall, built on a foundation of small assorted stones, set in clay mortar [B in *Fig. 7* bottom]. Only its southern end, exceeding 0.70 m in width, has been preserved. The function of the latter remains unknown, although one should note that it was built parallel to the wall of the *forica*.

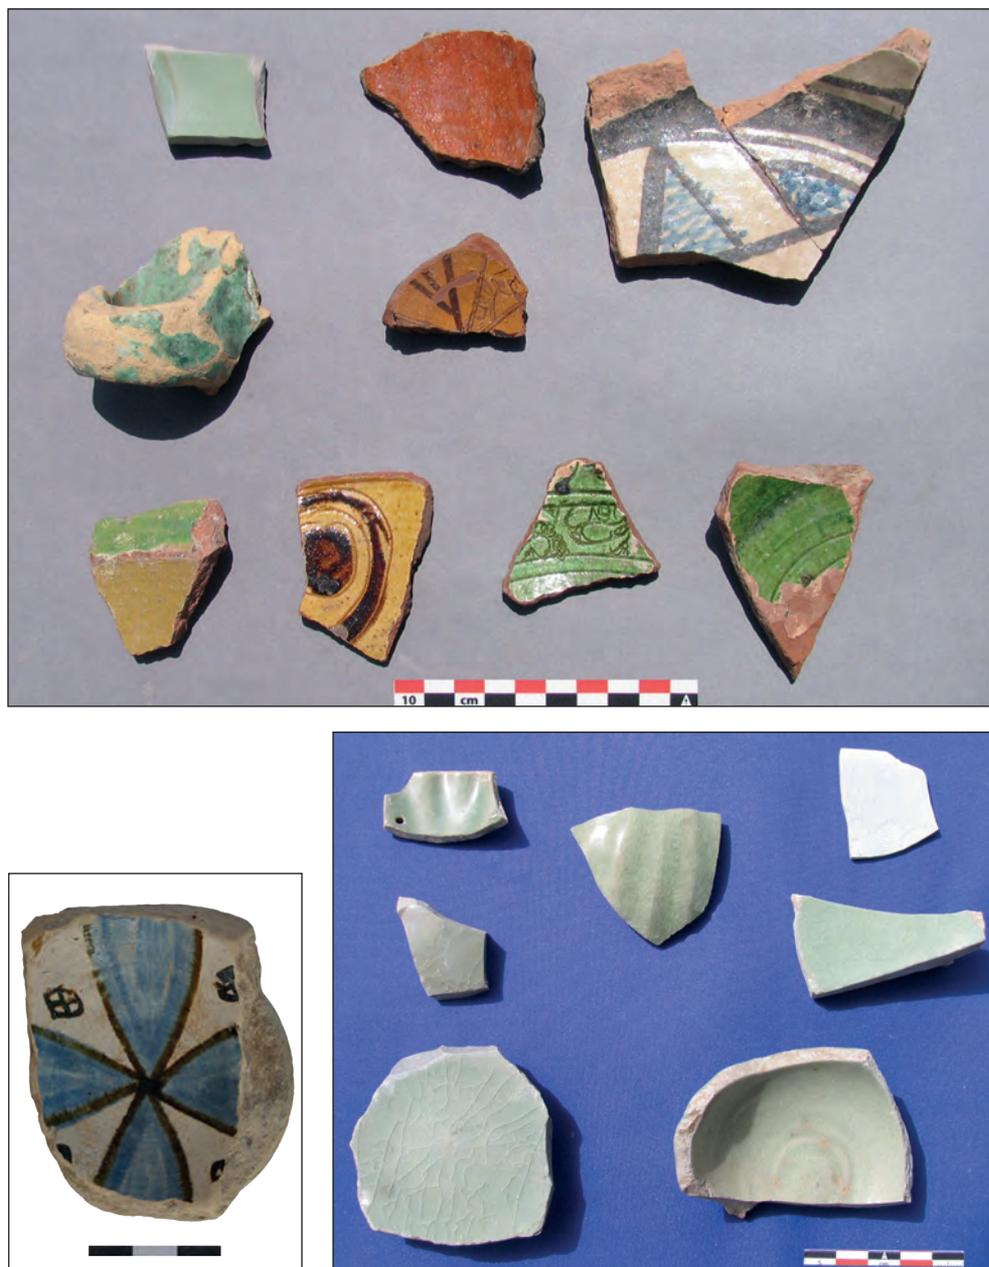
The strata overlying the necropolis proved to be particularly rich in pottery finds and produced the usual broad range of ceramics of the 12th–15th century AD originating from Egypt and other Mediterranean regions [Fig. 9 top]. Egyptian production was represented mostly by Mamluk Sgraff and Slip Painted wares. A waster from a Mamluk Slip painted bowl is an interesting find, pointing once again to the possibility of glazed pottery production in medieval Alexandria. Some Cypriote and Aegean examples were also

Fig. 9. Medieval pottery from layers overlying the cemetery in area U: top, Islamic glazed pottery, 12th–15th century; bottom left, Italian protomajolica sherd; bottom right, sherds of Chinese celadon wares (Photos G. Majcherek, A. Zawadzka)

Study and documentation activities centered on ceramological and anthropological studies. Medieval glazed pottery originating from various production centers in Sicily and southern Italy, mostly protomajolica wares from the 13th–14th century AD [see Fig. 9 bottom left], was studied by Anna Zawadzińska. Skeletal

identified. Western imports, although less numerous, were also recorded. Some tiny sherds of Spanish luster wares were found along with fragments of large Tunisian vessels of Hafsid date. Several glazed oil lamps of Ayyubid–Mamluk age were likewise recognized. Quite surprising was a relatively large number of fragments of Chinese celadon wares [Fig. 9 bottom right]. The same layers yielded also a blue glass coin weight, bearing a stamped inscription in Arabic.

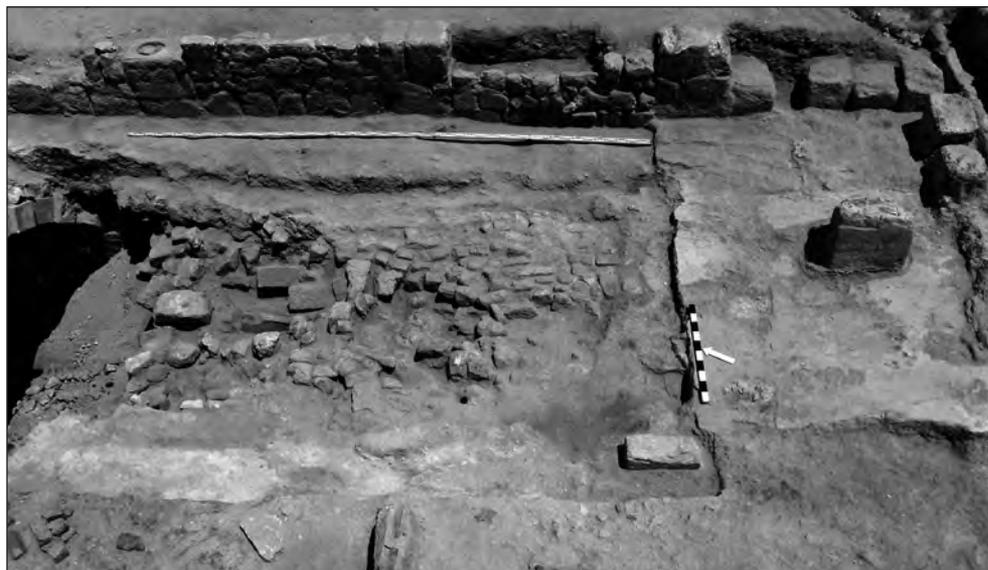
*Fig. 12. Underfloor layers and cleared extrados of the bath vaulted chambers, uncovered in auditorium B in area G (Photo A. Smilgin)*

Remnants of a vault were cleared immediately below. Although apparently subsided (in the middle part approximately 0.40–0.60 m) and structurally unstable, it

retained most of the blocks in the original position. An outer coating, made of small assorted stones set in ashy mortar, was preserved over a large part of the vault, applied directly onto the extrados.

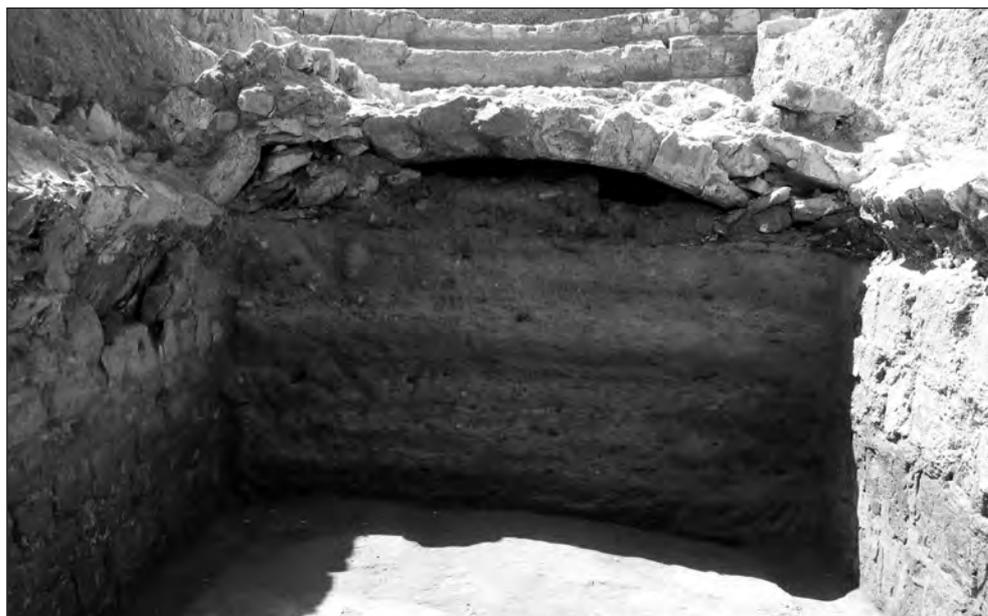
*Fig. 13. Collapsed vault of the bath entrance chamber, view looking south (Photo G. Majcherek)*

The vault, which was preserved on the whole as loose and dislocated blocks resting directly on accumulated fill, turned out to be shattered and subsided, but still strong in a few locations, to the extent that it retained space, 0.30–0.40 m high, under the keystones. All the identified layers accumulated there ran almost horizontally through the entire span of the underground chamber, pointing to a rather slow and regular deposition process [Fig. 13].

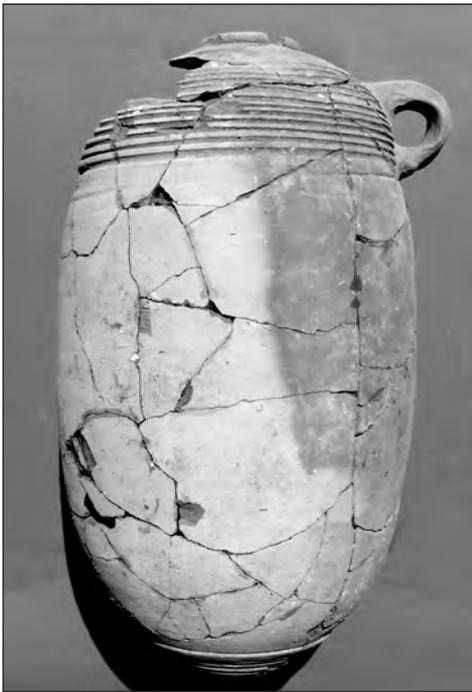
Fig. 15. Example of a Gazan amphora (LRA4a) from the H(e) test trench in area H (Photo G. Majcherek)

The cut of the foundation trench of the huge wall and the buttress was identified in the compact soil. Dating material from the trench and predating the accompanying layers was rather modest in number and largely inconclusive, consisting mostly of common ware sherds. Un unexpected find was a nearly complete Gazan amphora (LRA4a), found in the northeastern corner of the foundation trench [Fig. 15]. It must have obviously served as an impromptu burial, as evidenced by infant bones found inside it. Apart from some earlier, residual examples, most of the pottery finds pointed to the 4th century AD as the most plausible date for the wall construction event. It is

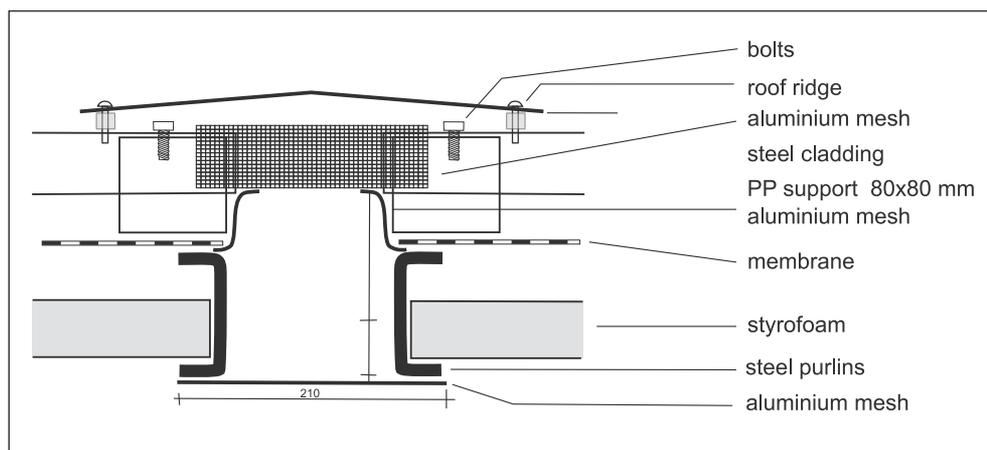
Fig. 16. Scheme of the aeration aperture in the shelter roof  
(Drawing Z. Nawrot, G. Majcherek)

The most demanding operation undertaken in the 2012–2013 seasons was the continued overhaul and upgrading of the roofing (by Zygmunt Nawrot). In order to reduce the high humidity inside the shelter and to avoid the risks of roof-space condensation, a vapour permeable membrane (mdm AQ 180) was introduced between the steel cladding and a Styrofoam thermal insulation layer. The operation commenced in 2011 (Majcherek and Kucharczyk 2014) and was completed in the 2012 season. Next, a simple aeration system that was found to be the most effective and low-cost form of ventilation was installed. In this system, air enters a room through the windows, doors, etc. and forces out the warm and damp air through ventilation skylights in the roof. To achieve the desired effect, specially designed exhaust apertures (about 1.5 cm high) were formed, following a thorough remodelling of the roof ridge made of triangular-shaped sheet metal, which was raised to achieve the purpose. It was now supported on bolts furnished with a rubber pad. The sheet iron welded along the ridge and screening it from inside was removed to create the 14.50 cm wide intake aperture along the entire length of the ridge (15 m). Corrosion-resistant aluminium wire mesh was installed to keep the openings free from being blocked (with environmental and urban-generated waste, etc.). Two strips of such mesh were installed: the one from inside (23 cm wide) was fixed to the steel rafters

[*Fig. 16*], while the outer one (18 cm wide) was laid on the corrugated sheet iron cladding. In both cases, the aluminium mesh was fixed with regularly spaced stainless bolts (3 mm). The system has proved to be fairly effective. Measurements with an electronic air velocity meter indicated that air flowed through the apertures with a mean velocity of approximately 0.9–1.0 m/s.

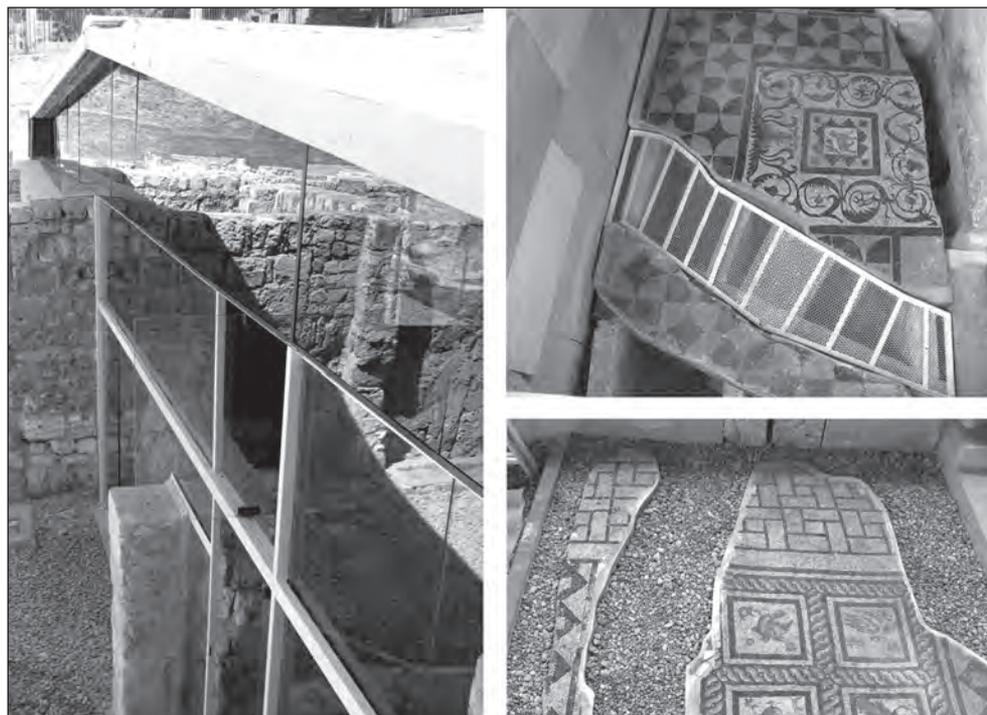
Fig. 17. Maintenance conservation in the Mosaic Shelter: left, repaired west glass wall; top right, ventilation grille around the mosaic with panther ( $\alpha$ -6); bottom right, restored edges of the mosaic with birds ( $\alpha$ -5) (Photos G. Majcherek)

Necessary repairs were made to the structure of the shelter itself, especially to the west wall of panel glass which had suffered extensive damages in the part of the gables and the gap between the shelter and adjoining architecture. Some of the smoked glass panels here had been broken and these were now reinstated. A new wall coping was shaped, and the gap itself covered with new panels set in fittings fixed to the shelter's horizontal steel frames [*Fig. 17* left]. They were laid slightly inclined outward to secure rainwater drainage and additionally secured with silicone foam to prevent leakage.

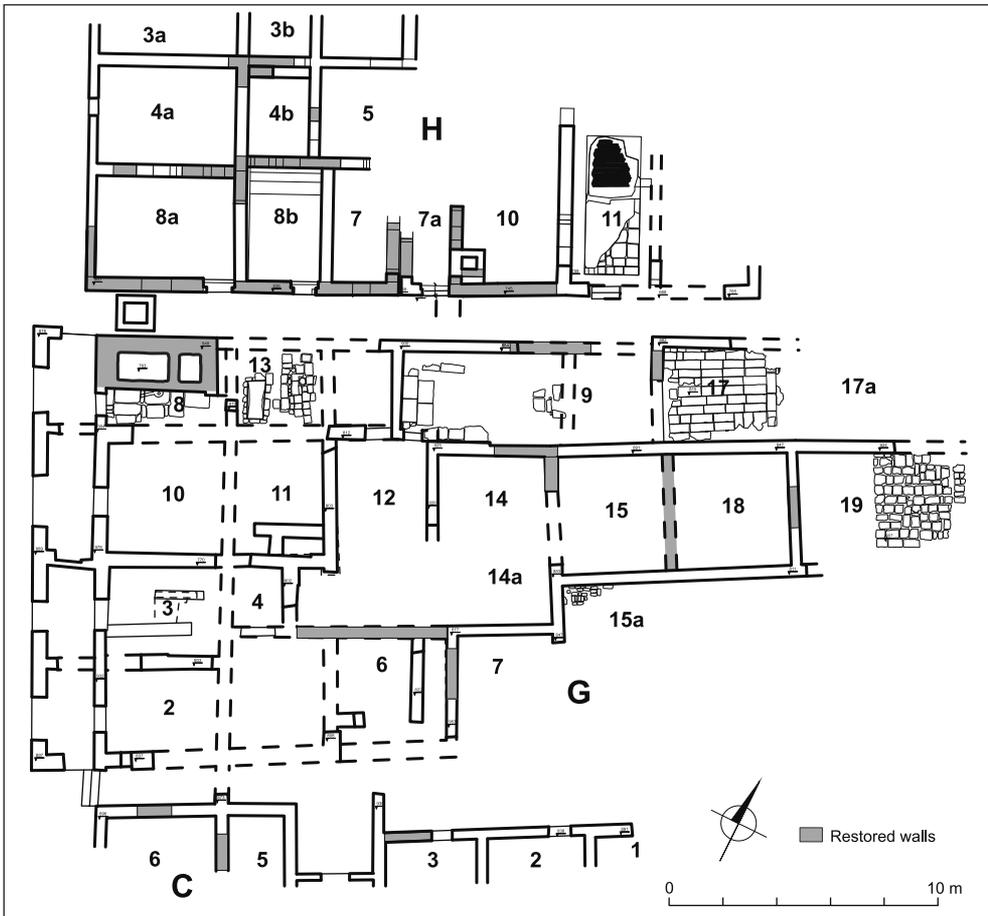
Fig. 18. Domestic quarter: plan showing walls restored in the 2012 and 2013 seasons (Drawing G. Karpińska, M. Polak)

In the 2012 and 2013 campaigns these procedures were applied to a series of pre-selected walls. Wherever necessary, the most deteriorated stones were replaced. Well seasoned blocks obtained from nearby excavations were used in such cases. All joints were repaired and com-

pleted with new mortar. In order to prevent further water penetration, new wall copings were shaped using new stones separated with a layer of bitumen tar paper, acting as an insulation layer as well as a marker separating modern wall fabric from the ancient one. Similar rules were also adopted in other limited restoration operations.

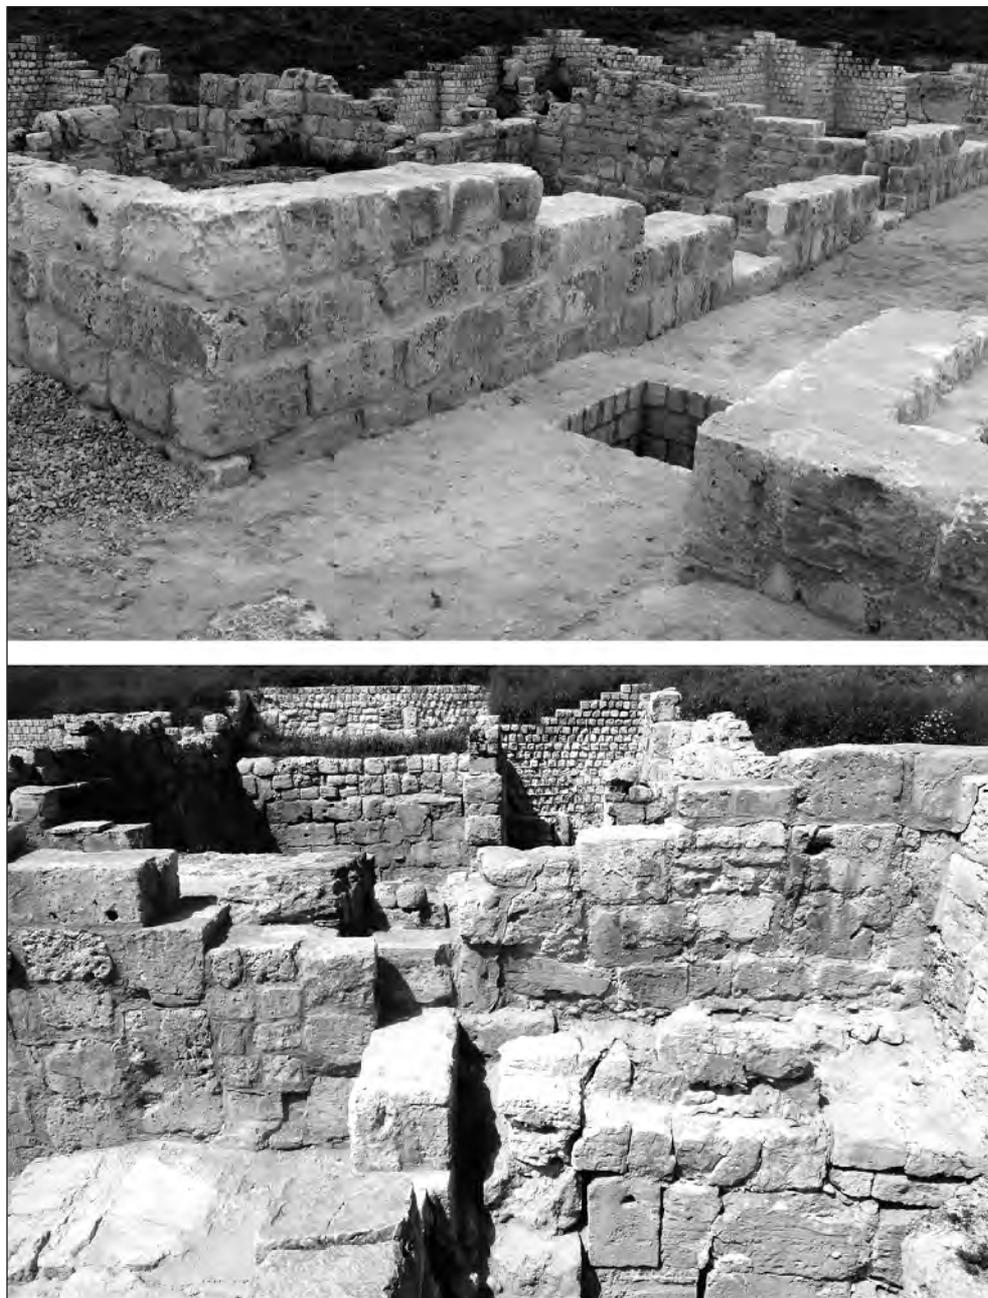
*Fig. 19. Restoration in the domestic quarter: top, southwestern corner of building H after restoration; bottom, restored north wall of rooms H8a and H8b (Photos G. Majcherek, M. Polak)*

parallel walls (approximately 1.60 m long), structured in large blocks of dressed stones, between rooms H7 and H7a, were partly restored. In the late Roman/early Islamic period, these walls were already robbed to the foundations. Two new courses of stone were laid, bringing the whole structure some 0.60 m above ground level.

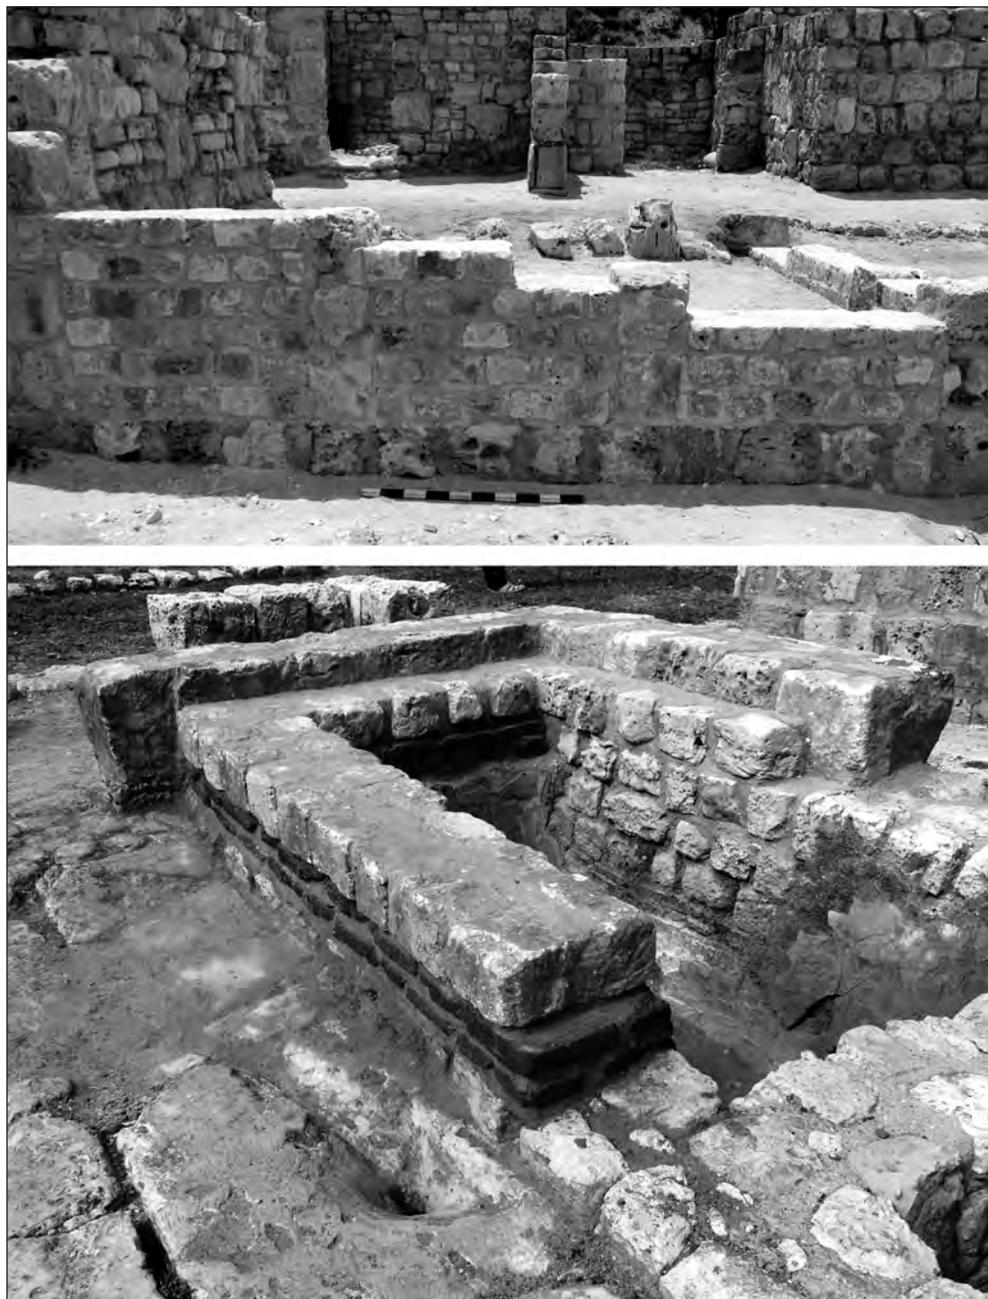
*Fig. 20. Restoration in the domestic quarter: top, north wall of room G6 after restoration; bottom, basins in room G8 following conservation (Photos G. Majcherek, M. Polak)*

Basins located in room G8 (northwestern part of house G) were also subject to

conservation measures. They were uncovered already in the 1989 season and were then temporarily protected (Majcherek 1990: 82–83, Fig. 1). The complete installation consists of two basins of unequal size (the larger one measuring 1.00 m by 1.85 m, the smaller one 1.00 m by 0.85 m). Both were constructed in mixed technique, of small stones and bricks set in mortar with substantial amounts of ashes added. On the inside of the basins the walls were covered with a red *opus signinum* (*cocciopesto*) plaster. Each of the basins was furnished with an outlet for discharging the fluid contents. The western, northern and southern sections of their mixed stone

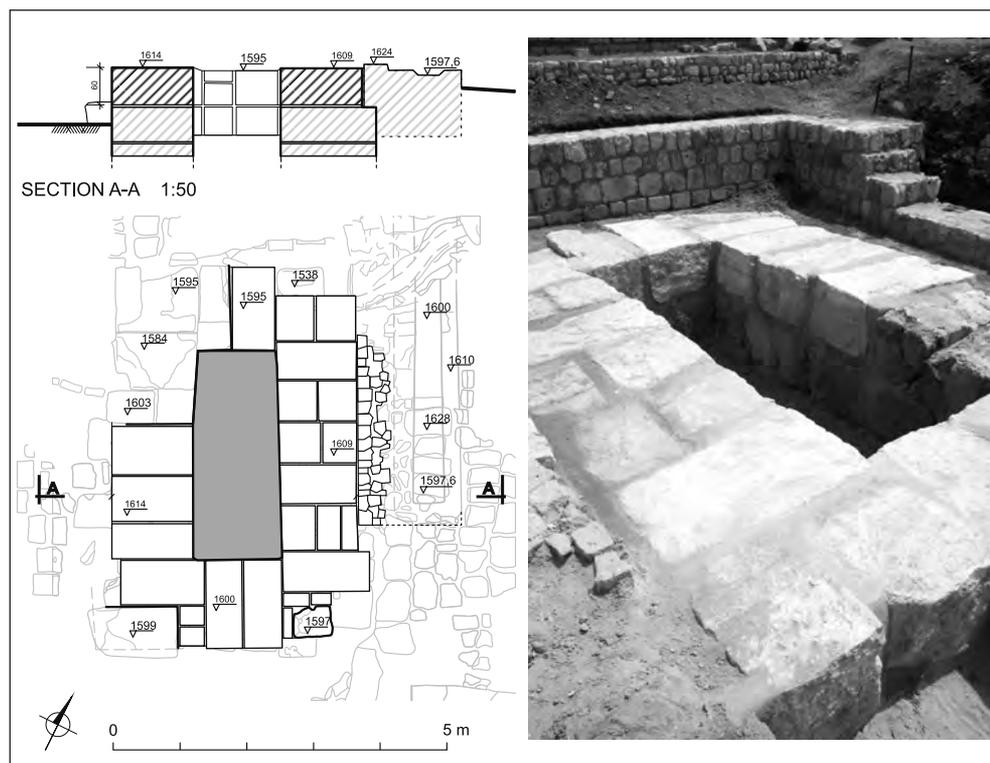
Fig. 21. Southwestern well in the cistern: left, plan; right, view after restoration (Drawing and photo A. Pisarzewski)

A large well located in the southwestern part of the cistern was restored, completing a project initiated in 2011 (under the supervision of Aureliusz Pisarzewski). The well head, originally made of extremely large blocks (some exceeding 1.20 m in length), was entirely restored. New blocks of dressed stones were set in prescribed

position and fixed with mortar [Fig. 21]. An adjacent section of the water channel was also consolidated and repaired.

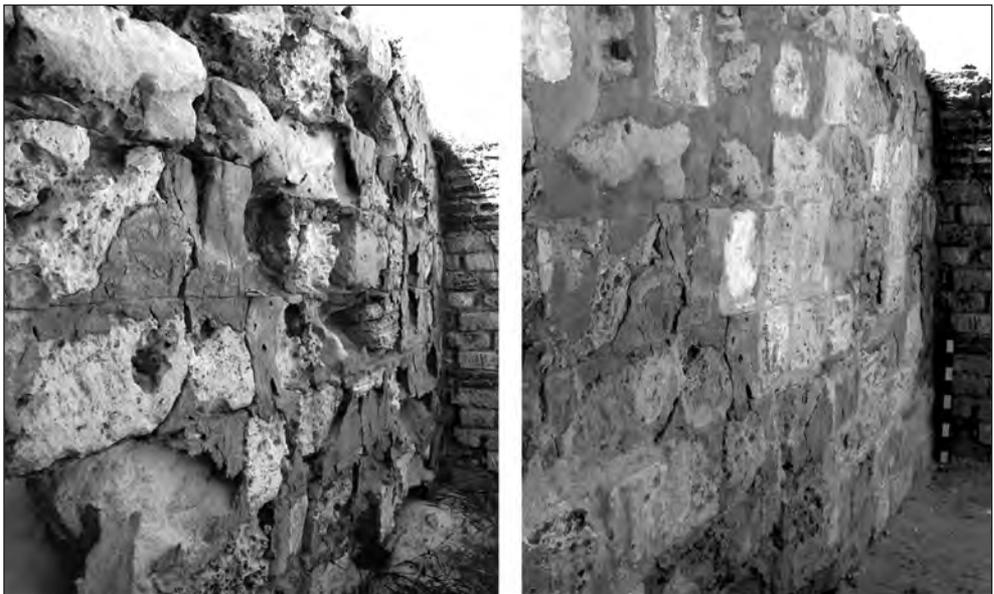
Fig. 22. North wall of the cistern: left, before, and right, after conservation (Photos G. Majcherek)

Monitoring revealed that some sections of the original cistern walls had suffered from long-term exposure to the elements. Some mortar joints had totally disappeared, wide and deep cracks were common, and several low quality masonry blocks lost more than half of their original mass. Such walls were in imminent danger of collapse. This was the case of a large wall (No. 30) built in the northwestern part of the building across earlier structures (corridor and adjacent water tanks).

The wall, 8.50 m long and preserved 3.00 m high in places, arching slightly northward, required immediate intervention. Constructed in the latest phase of the cistern (6th century AD), it was originally built of large regular masonry blocks (0.30 m by 0.40 m) set in lime mortar (Rodziewicz 1986). All the joints were now thoroughly repaired, missing or deteriorated blocks were replaced with new similar ones and the whole structure stabilized [Fig. 22].

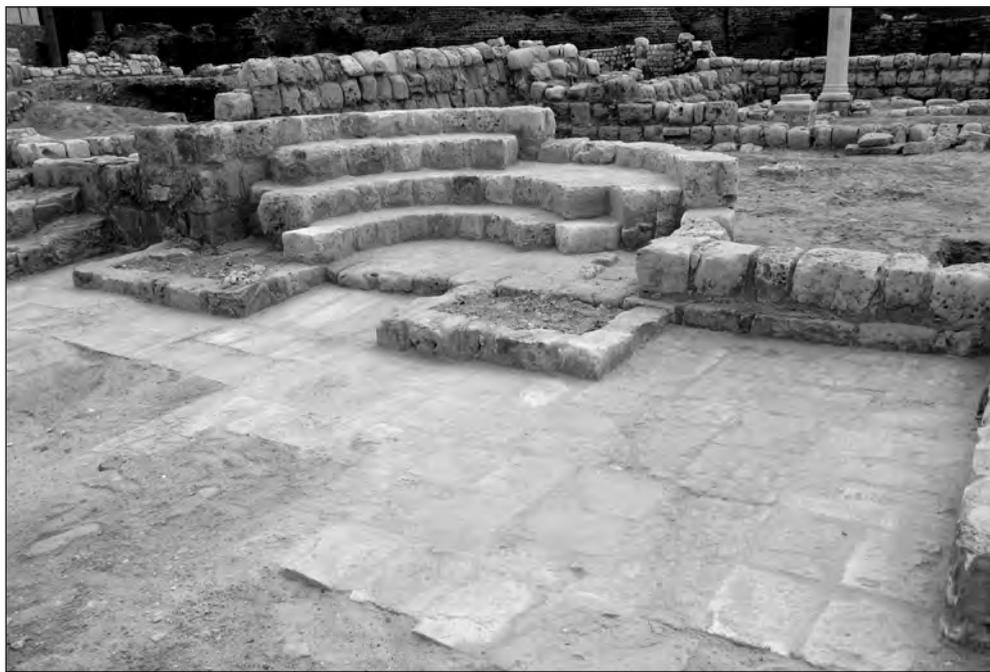
*Fig. 23. Apse and pavement in auditorium S after restoration  
(Photo A. Pisarzewski)*

In this part of the auditoria complex, the restoration of auditorium S was the main focus of activities (supervised by Aureliusz Pisarzewski). Some work was performed already in the 2007 season, when the building apse was restored (Majcherek 2010). Two rows of the damaged or missing benches were restored in 2012, as well as an adjacent part of the apse. The benches in the apse were found to extend originally some 0.80–0.90 m into the room. A northern box-like base supporting those benches was found to be fairly well preserved, while the southern one was gone entirely. The dimensions of the latter can be established, however, thanks to the imprints left in the pavement of the room. It was restored to the full height of the preserved northern base, i.e., one course of blocks above the pavement (approximately 0.35 m). Neighboring wall sections were also treated,

missing joints completed and the whole structure reinforced. In addition, the topmost bench approximately 1.20 m long was reconstructed along the south wall of the room. An equally important operation was the reconstruction of the missing patches of pavement. This was done not only in view of enhancing the aesthetic value of the extant edifice, but also in order to protect existing remnants of the pavement. Limestone pavers (some 7–10 cm thick) found during the excavations in this area were used for this purpose. Given their find spot, it is quite possible that they may have originated from the pavement. At least three large missing sections of pavement located in the eastern part of the building were now restored. Newly added pavers (1.00–1.20 m long) were laid following the original design [Fig. 23].
