On Inca astronomical instruments: the observatory at Inkaraqay – El Mirador (National Archaeological Park of Machu Picchu, Peru)¹

Fernando Astete Victoria, Mariusz Ziółkowski
and Jacek Kościuk

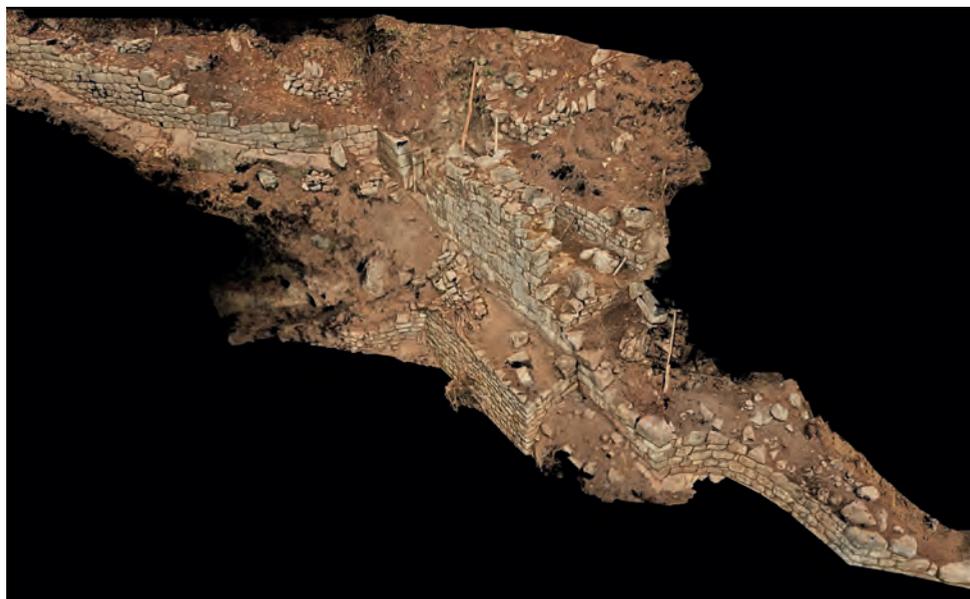
Figure 3. 3D Photogrammetrical model of the site as seen from the North (photos and photogrammetry by Ciechosław Patrzalek and Jacek Kościuk).

Behind the wall with the niches, there is a narrow (roughly 1.5 m) corridor. Its back wall is built directly against the slope of the hill. Stone masonry is executed from rectangular stones placed in a horizontal pattern. We believe that this wall must once have been plastered, as it was common practice in the Inca architecture, especially in the case of building with prestigious, ceremonial functions. It could be of particular importance in facilitating observations of sun rays passing through the opening in the northern niche, which will be discussed further (Fig. 3, 4, 15).

- A three-dimensional model of the structure was made on the basis of photogrammetry (Fig. 3,4), used for a computer analysis of its possible astronomical functions. Stellarium 0.12.4 and Cartes du Ciel (Sky Charts) 3.8 software were used for the simulation.

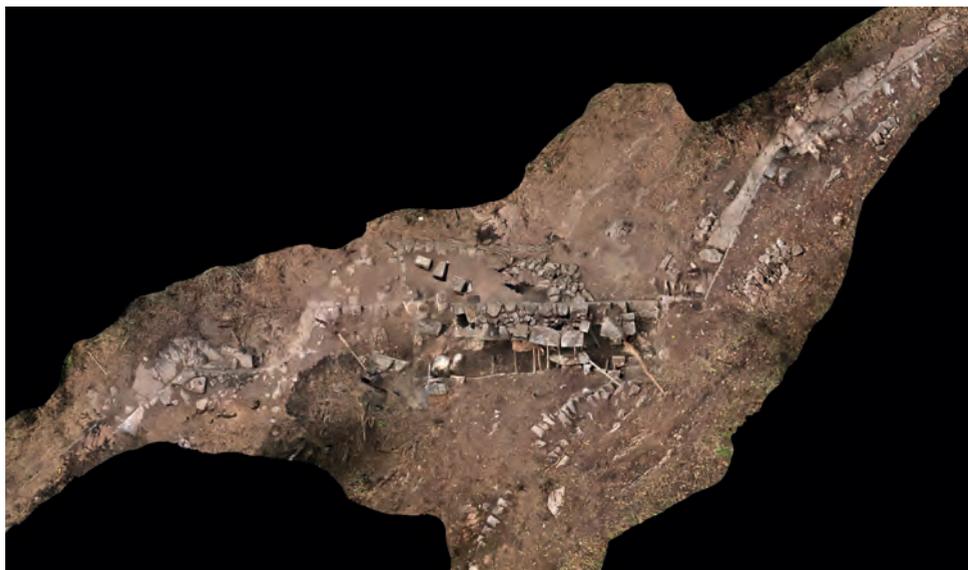
Figure 4. 3D Photogrammetrical model of the site – vertical view (photos and photogrammetry by Ciecchosław Patrzalek and Jacek Kościuk).

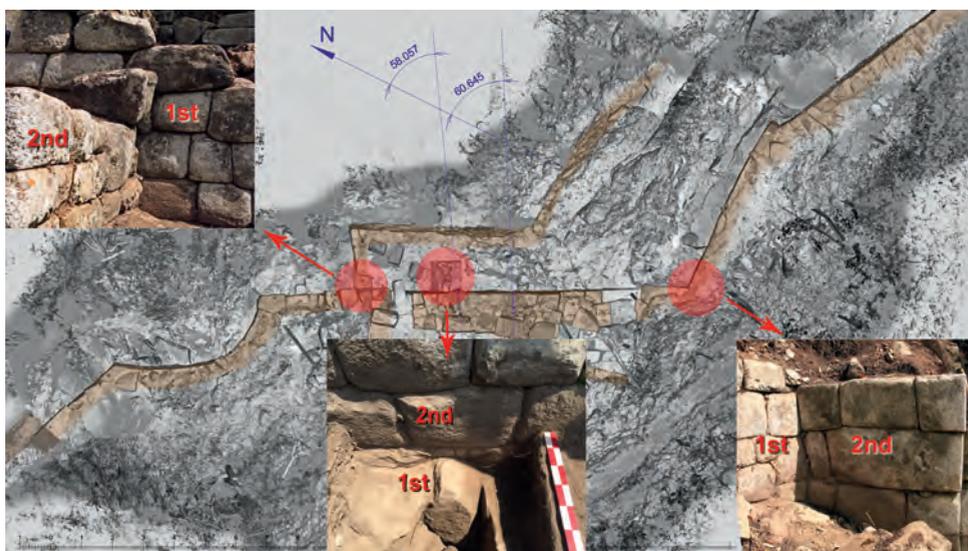
Figure 5. The plan of Inkaraqay-El Mirador and the main links between different building phases (photos and drawing by Jacek Kościuk).

Although the detailed examination is still in progress, preliminary conclusions concerning the order in which particular walls were erected, can be already offered. They are based mostly on observations of vertical joints between the walls, clearly indicating construction sequence (Fig 5).

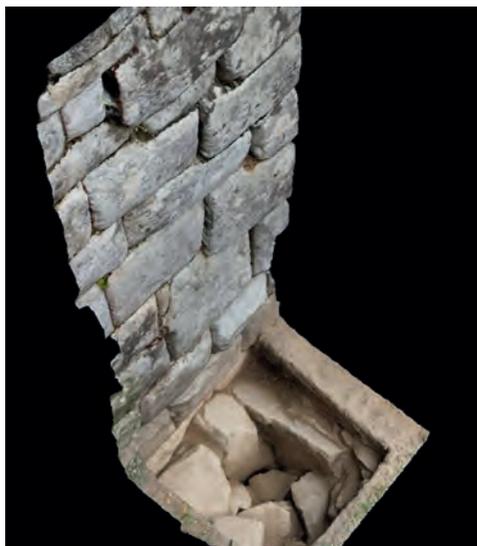
Figure 6. Photogrammetrical 3D model of the small test trench built at the foot of the main wall (photos by Jose Bastante Abuhebd, photogrammetry by Jacek Kościuk).

The 1st step (Fig. 7 – in red) was to build a foundation platform on the steep slope of the natural bedrock (Fig. 6). Parallely, further to the south, a retaining wall was erected on the top of carefully leveled bedrock. Probably its function was to stabilize the slope of the hill. During the 2nd building phase (Fig. 7 – in green), the main wall with niches together with its lateral extension to the north was erected. Probably at the same time another retaining wall has been added to the south. The 3rd step (Fig. 7 – in yellow) was to add facing to the foundation platform erected dur-

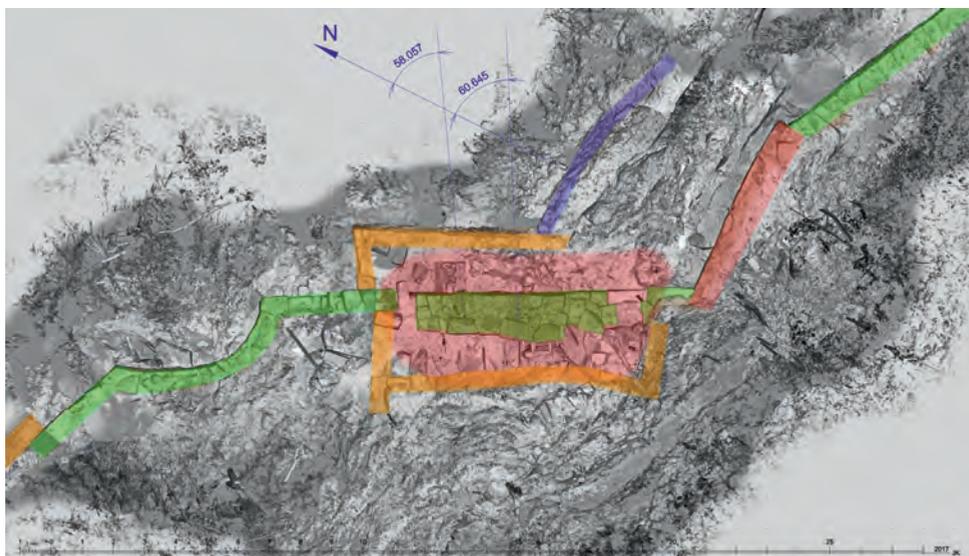
Figure 7. The main chronological phases of construction (drawing by Jacek Kościuk).

ing the 1st phase. At roughly the same time, the back wall of the whole building has been added, as well as a further, northern continuation of the retaining wall. The limits of northern and southern extents of the retaining wall are still to be traced. During the last, 4th phase (Fig. 7 – in blue) a small retaining wall was added in order to provide a secure access to the platform in front of the main wall.

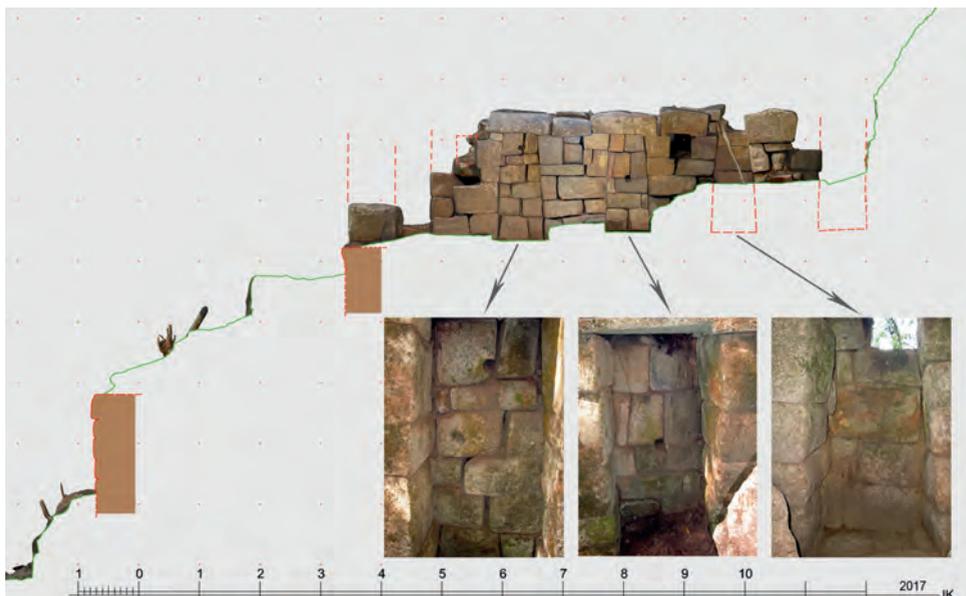
Figure 8. The back face of the main wall with 3 niches (drawing and photos by Jacek Kościuk).

On the back of this latter wall, two sets of niches are extant. Three of them, roughly 1.6 m high, start directly above the floor of the building. They are approximately 70 cm in width. The middle niche and the most northern one are equipped with two observation openings (Fig. 8, 9).

floor.⁴ There was also a third niche of this kind. Its southern edge is still preserved north of the northernmost big niche (Fig. 8).

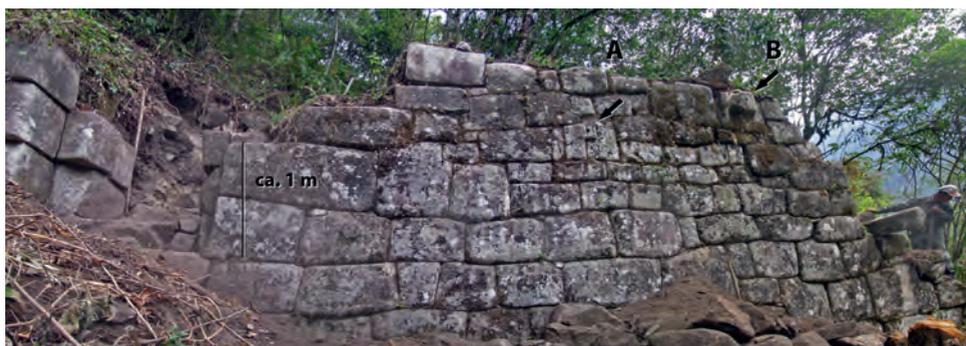
Figure 9. The Inkaraqay – El Mirador façade. Arrows indicate the outlets of observation openings (photos: Mariusz Ziółkowski, stitching panorama and description: Jacek Kościuk).

Inkaraqay – El Mirador is a small structure situated on the northern slopes of Huayna Picchu (Fig. 1, 2). Architectural remains, which are still preserved on the site, consist of three parallel walls placed perpendicularly to the steep slope of the hill. The lower wall serves as a retaining wall stabilizing footings of the building situated above. At the same time, it creates a narrow (ca. 1.75 m) platform facilitating access in front of the building. The middle wall is ca. 1.25 m wide and its façade is preserved to a height of ca. 3.5 m. The carefully executed stone masonry is of a pseudo-coursed kind with slightly sunken joints. This type of stonework is characteristic for buildings of the highest importance and prestige (Fig. 9).

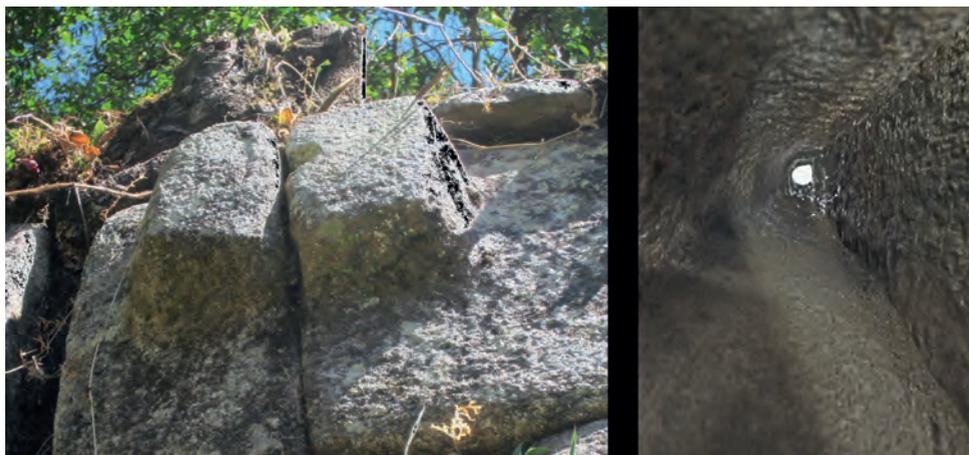
Figure 10. The northern observation opening: the outlet on the façade (left – photo: Mariusz Ziółkowski) and the interior (right – photo: Jacek Kościuk).

It should be emphasized that the openings have been made in a very careful and structurally well thought out manner (Fig. 10,11). Analysis of the construction process allows for the hypothesis that the said wall was planned according to the appropriate placement and orientation of these apertures. The manner of making the observation openings is of par-

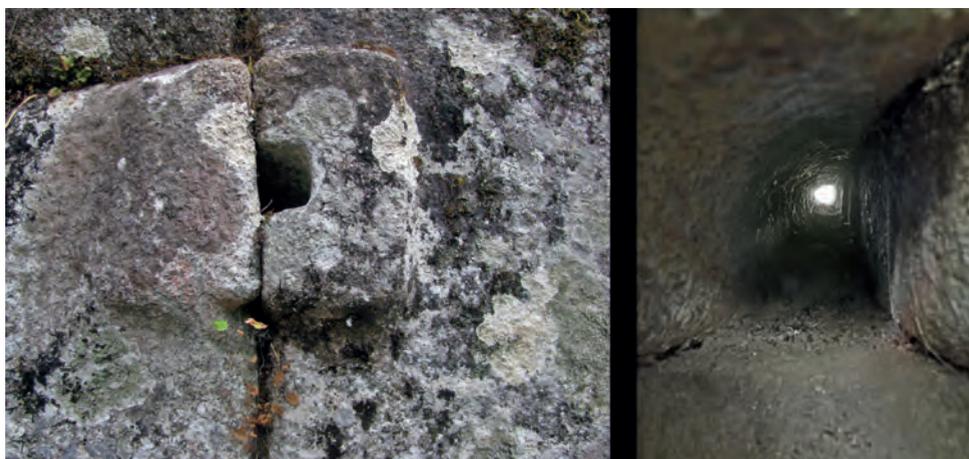
Figure 11. The southern observation opening: the outlet on the façade (left – photo: Mariusz Ziółkowski) and the interior (right – photo: Jacek Kościuk).

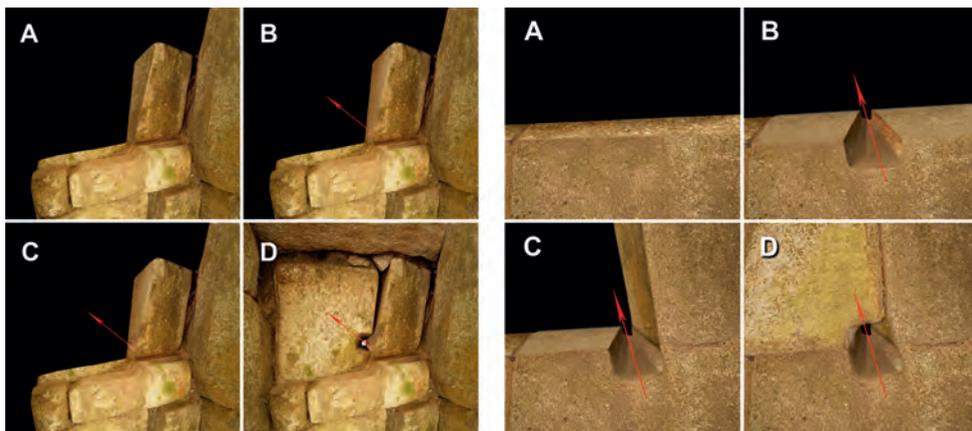
Figure 12. The reconstruction of the sequence of the northern opening construction (left) taking into account the method of determining the very precise horizontal orientation and the reconstruction of the sequence of the southern opening construction (right) where less precise vertical orientation was required (reconstruction by Jacek Kościuk). Compare with the precise description of the process in the text.

ticular importance. It can be traced especially well in the case of the northern niche (Fig. 12, A-D). First, in the space designated for the opening, a stone block with a slightly sloping north face was embedded (Fig. 12 A). The orientation of thus prepared face indicated approximately the point of sunrise over the Yanantin summit during the June solstice. The next step was a correction of the north face of the block so that its plane crossed the horizon line at desired position (Fig. 12 B). In the next step, probably following the June solstice observation, a shallow canal was carved in the already prepared northern face of the block, indicating precisely the point of

sunrise over the summit (Fig. 12 C). The final step was the addition of another block with an already carved, much deeper groove (Fig. 12 D). The southern observation opening was made the same way. It seems, however, that in this case, the zenith angle was more important to the builders than the azimuth angle; the entire process was started not with the orientation of the lateral azimuth of the vertical face of the first block but on the contrary, from the zenith orientation of the top horizontal plane of the block in which the observation channel was then made (Fig. 12, A-D).

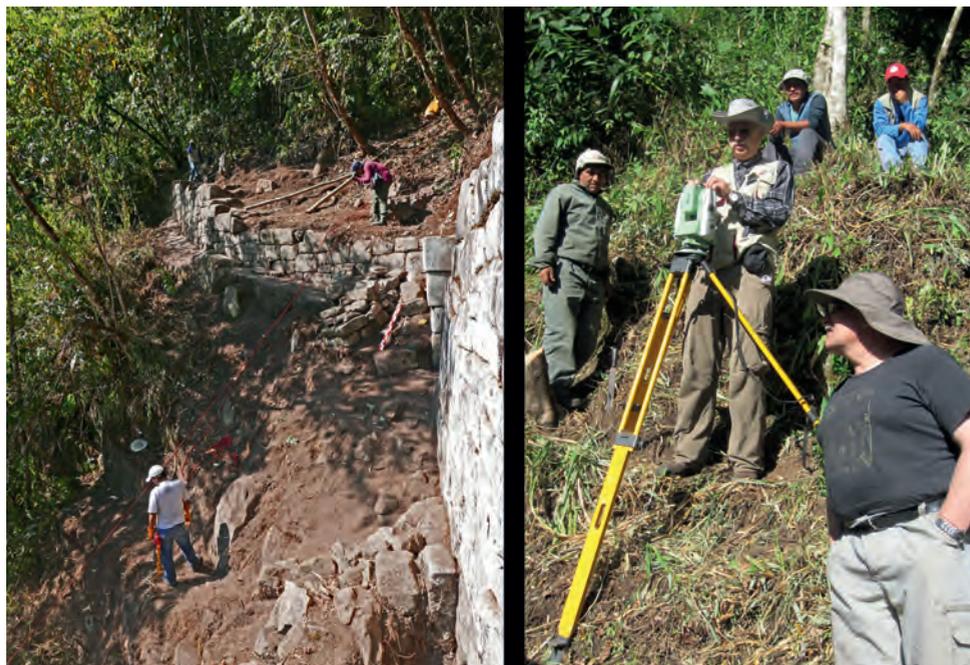
Figure 13. Inkaragay – El Mirador site at the beginning of fieldwork in 2013 (left photo: Mariusz Ziółkowski) and the archaeo-astronomical survey (right photo: Adine Gavazzi).

In August 2012, the personnel of the Archaeological Park of Machu Picchu carried out archaeological research at Inkaraqay. At the same time, a preliminary topographical plan of the structure was made. Between 2013 and 2017, the Peruvian-Polish research team performed the following important work (Fig. 13):

In both cases, the horizon line (and the related visible part of the sky) is determined by the summit and slopes of the Yanantin mountain (Fig. 2 right, 13).

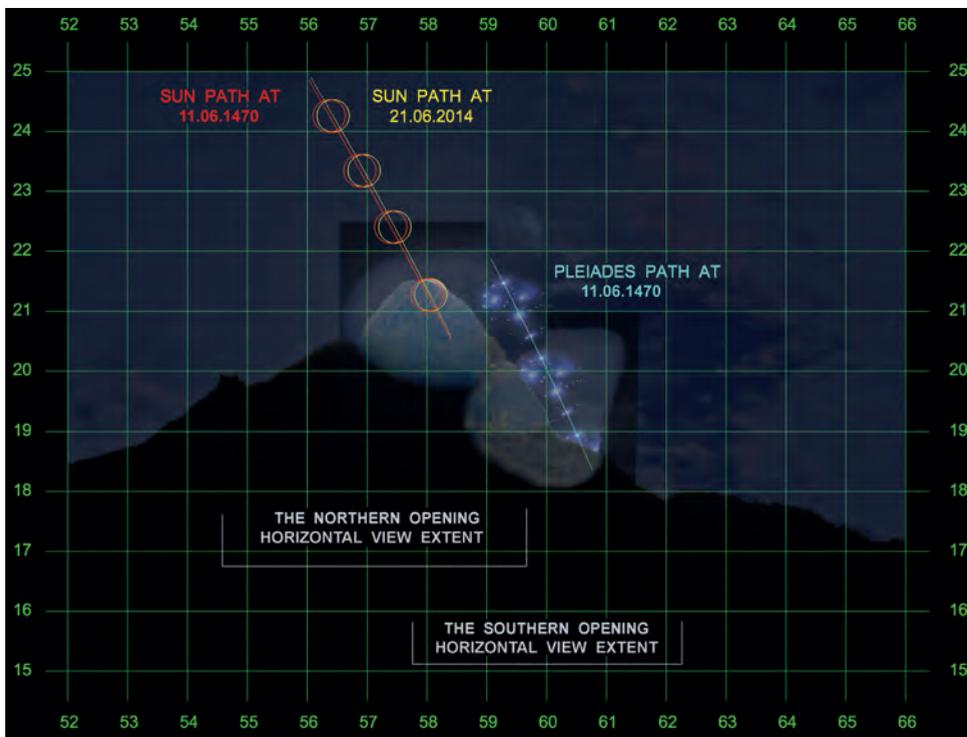
Figure 14. Reconstruction of the conditions for observing the sky through both openings showing view fields alongside their main axes. The lower scales (in grey) show the maximum range of visibility from each opening when changing the position of the observer's eye. The yellow path represents Sun positions during June Solstice Sunrise observed (and photographed) on 21.06.2014. JSSR in 1470 AD, the approximate date of the construction of the building, is marked as the red path. The reconstructed positions of the Pleiades in 1470 AD, as seen through the southern opening, are represented in blue (reconstruction by Mariusz Ziółkowski and Jacek Kościuk using Cartes du Ciel 3.08 and Stellarium 0.16.0 software).

through the north opening directly above the Yanantin summit during the June solstice (Fig. 14). The accuracy of the model analysis was thus confirmed, which allowed it to be used to reconstruct the sky at the end of the fifteenth century, the approximate period of the erection of the structure (for the purposes of analysis the year 1470 AD was arbitrarily chosen)⁶. Part of the findings obtained in this manner is shown on Figure 14. The main results of this analysis, for reason of precision, are discussed in points:

1) It was already mentioned, that the most spectacular phenomenon is observing the Sunrise right over the Yanantin summit during the June solstice. This phenomenon is visible through both openings but centered in the northern one (Fig. 14 left). It should be noted, however, that observation with the naked eye is possible only in the initial phase of the phenomenon; once the entire solar disk is above the horizon, its glow is too blinding. One can hypothesize that in this particular case, this opening was used not for horizontal but gnomonic observation, following a ray of sunlight falling on the back wall of the structure (Fig. 15). We can

2) The path of the Pleiades during their heliacal rising could also be observed through both openings, but mainly through the southern one. This phenomenon was particularly spectacular, as at the end of 15 c. AD, the Pleiades seemed to be “climbing” in their transition along the southern slope of the Yanantin mountain (Fig. 14 right, 16).

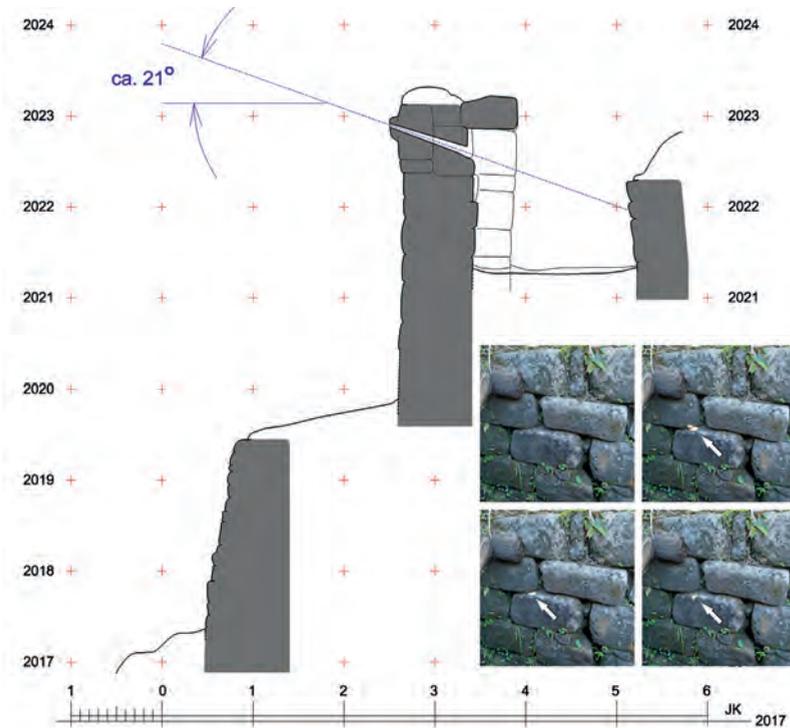
Figure 15. Vertical cross-section of the northern opening, indicating how the sunrays fall on the back wall of the chamber at June Solstice Sunrise (left - drawing by Jacek Kościuk). Photographs showing the movement of sunlight on the back wall of the chamber on June 21st, 2014 (right – photos: Jacek Kościuk). Originally, the wall was most likely covered with plaster, which greatly facilitated gnomonic observation.

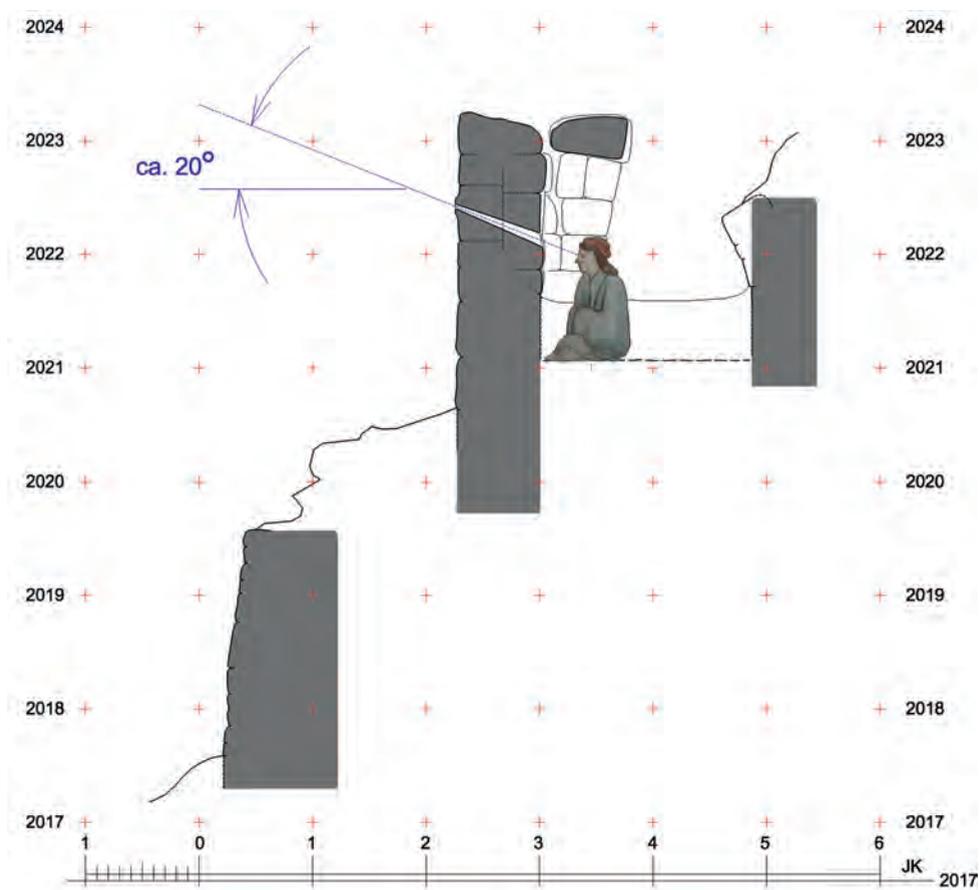
Figure 16. Vertical cross-section of the southern opening with the hypothetical reconstruction of a priest-observer position (drawing by Jacek Kościuk).
