ALEXANDRIA

EXCAVATIONS AND PRESERVATION WORK

PRELIMINARY REPORT 2006/2007

Grzegorz Majcherek

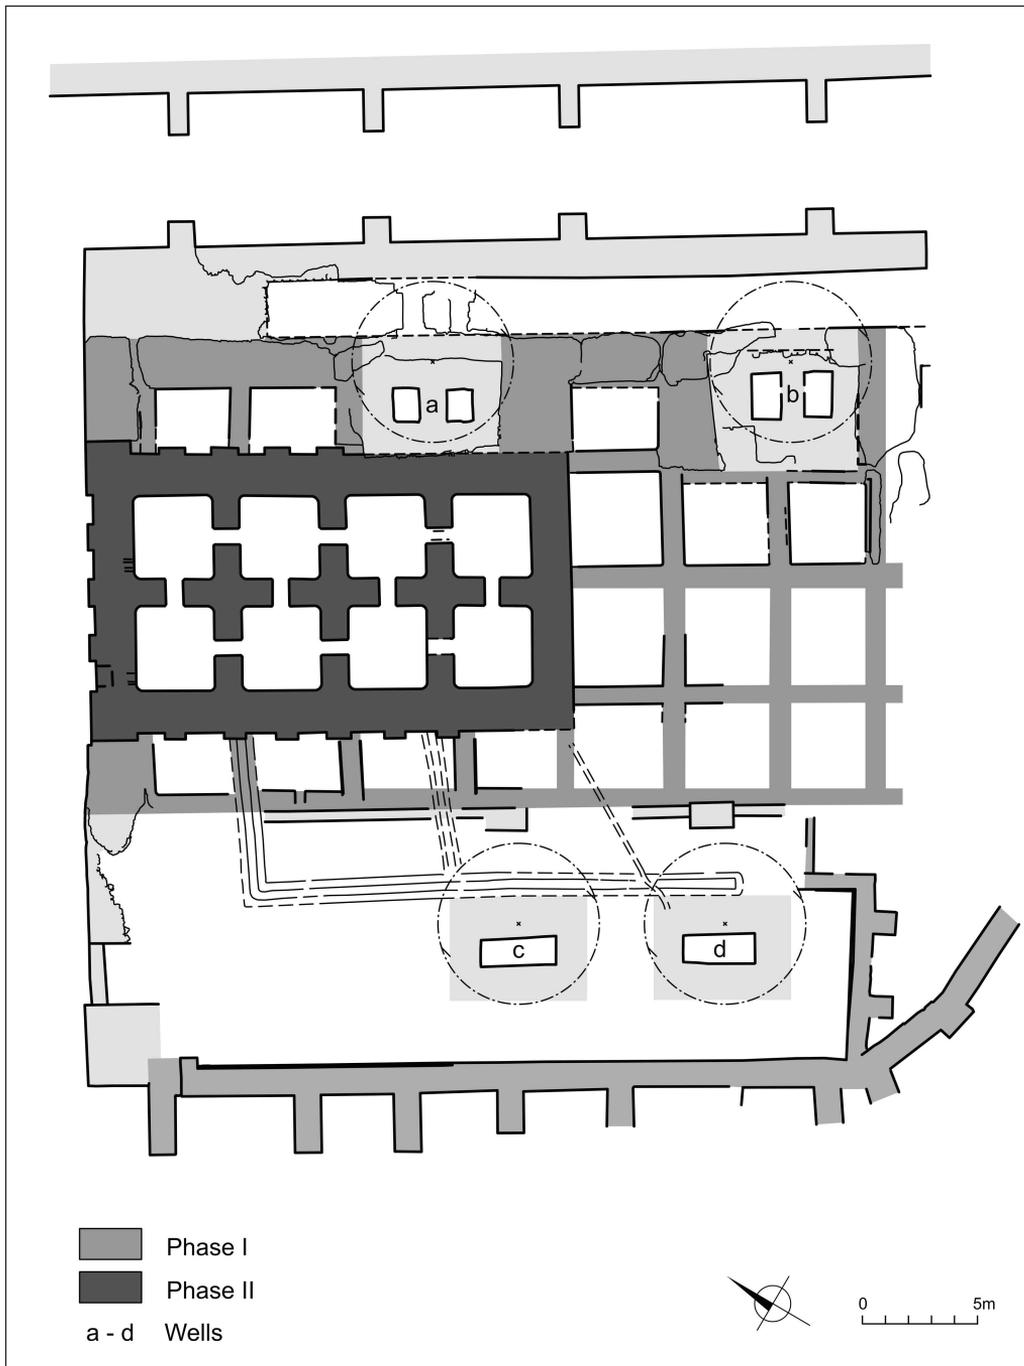
Fig. 1. Plan of the cistern installations from different phases
(Drawing W. Kolątaj, updated by A. Brzozowska)

Last year's clearing of an extant fragment of the medieval Moslem cemetery overlying the southwestern part of the cistern (the highest point on the site) opened the way to the exploration of vestiges of the cistern installations below [*Fig. 1*].

Two large wells were cleared directly below (marked *c* and *d* in the plan in *Fig. 1*).

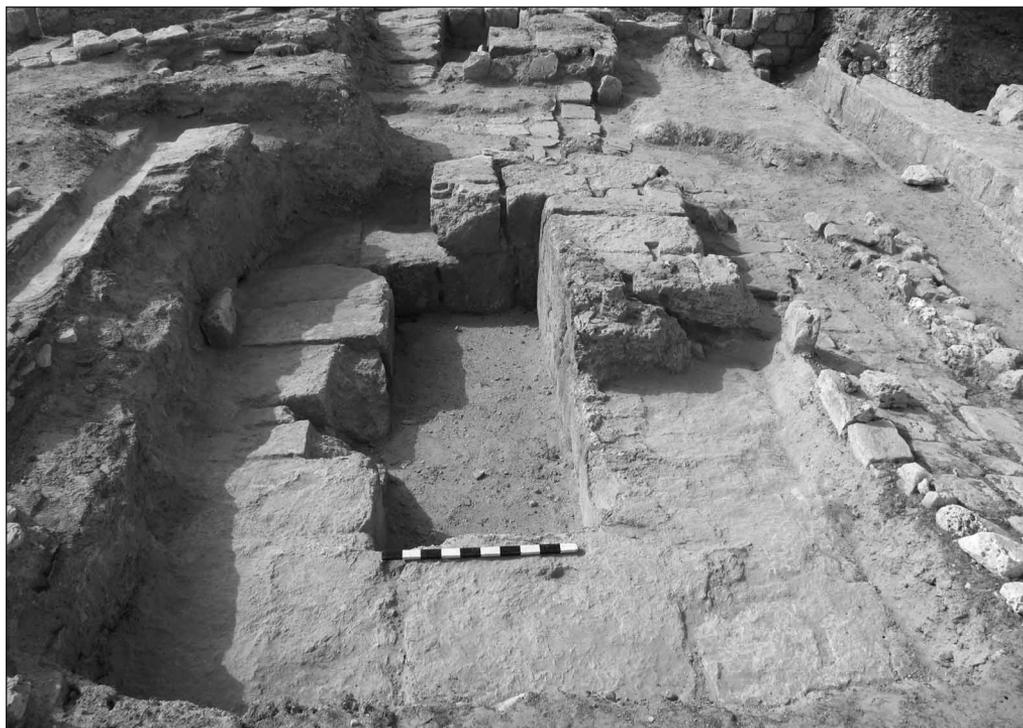
Both structures are rectangular in plan, measuring approximately 1.25 x 3.25 m. The shafts were built of surprisingly massive masonry, some of the blocks measuring even 1.10 x 0.60 x 0.55 m [*Fig. 2*]. The blocks were additionally joined with metal clamps, as evidenced by large openings of dove-tailed shape on their surfaces. The heads of the wells are not preserved; they were damaged most probably even before the medieval burials encroached upon the area. The walls inside turned out to be heavily incrustated with calcium–lime deposits,

Fig. 2. Masonry wells in the southwestern part of the cisterns, view from the north (Photo G. Majcherek)

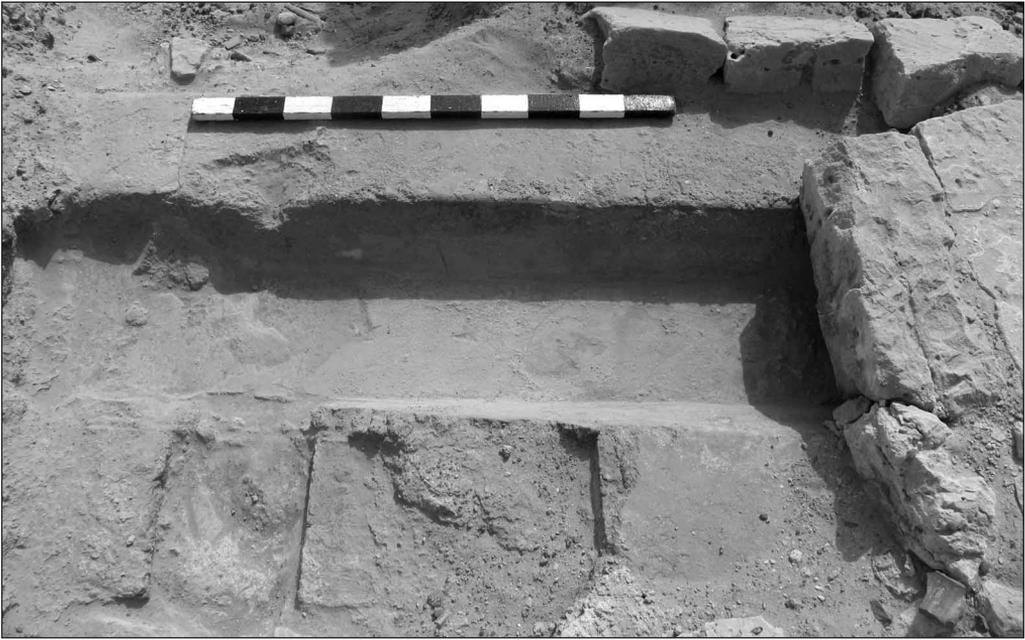
*Fig. 3. Channel from the drawing well to the tanks, view from the east
(Photo G. Majcherek)*

Last season, a stretch of water-channel feeding the cistern was cleared next to the wells. It appears to have supplied water from the nearby drawing well to the cistern tanks located further along. The channel, which is trapezoidal in section, was built of red bricks (28 x 28 x 4.5 cm) lined with waterproof plaster and covered with horizontal limestone slabs [*Fig. 3*]. It was laid on massive foundations (1.40 m wide and 0.85 m deep), made of several layers of bricks interlaced with small limestone blocks. This year an additional bifurcation of the channel was cleared next to the southern well. It was built as a double-level channel, to control water distribution to particular tanks. Both wells were in operation during the second phase of the cisterns and went out of use sometime in the 6th century. By the time the last set of tanks was constructed, they were already abandoned and covered with limestone flagging (for previous excavations in the cisterns area, see Kubiak 1967: 47–81; Rodziewicz 1984).

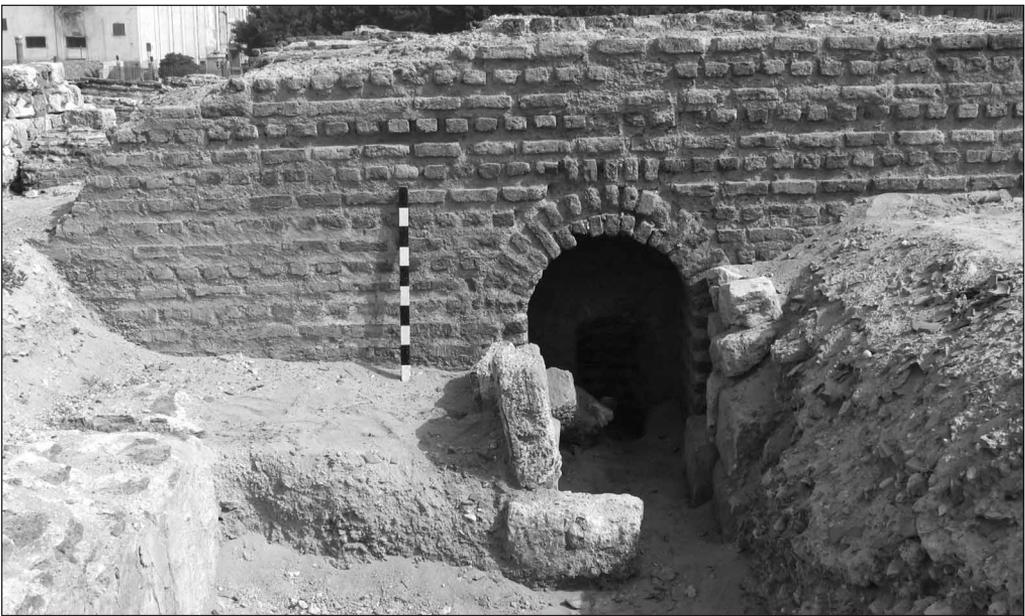
*Fig. 4. Water outflow from the last-phase cistern, view from the south
(Photo G. Majcherek)*

Quite unexpectedly, explorations of the previously unexcavated southwestern tank of the last-phase cistern revealed an additional water outflow [*Fig. 4*]. The outflow pipe (not preserved) had been placed at the bottom of the tank, within a vaulted opening some 0.85 m wide and 1.55 m high. There can be no doubt as to its

contemporaneity with the original construction. A likely interpretation is that it was supposed to supply water to yet another public building (possibly baths as well) located further to the south, beyond the limits of the excavation area.

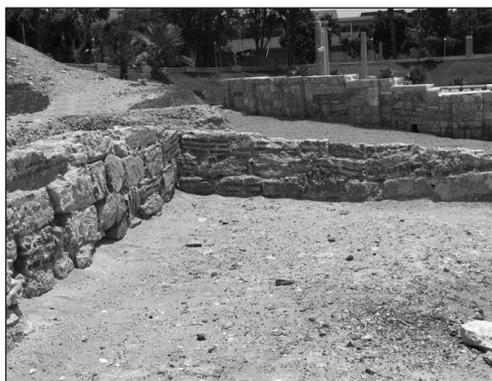
adding to its height in its southern run, close to where it joins a wall of similar masonry bordering the theatre on the north [Fig. 5]. The added courses consisted of large blocks cut from brick walls, quite likely from the abandoned water tanks in the cisterns or baths.

Fig. 5. *Dump-retaining wall in central part of the site, view from the north*
(Photo G. Majcherek)

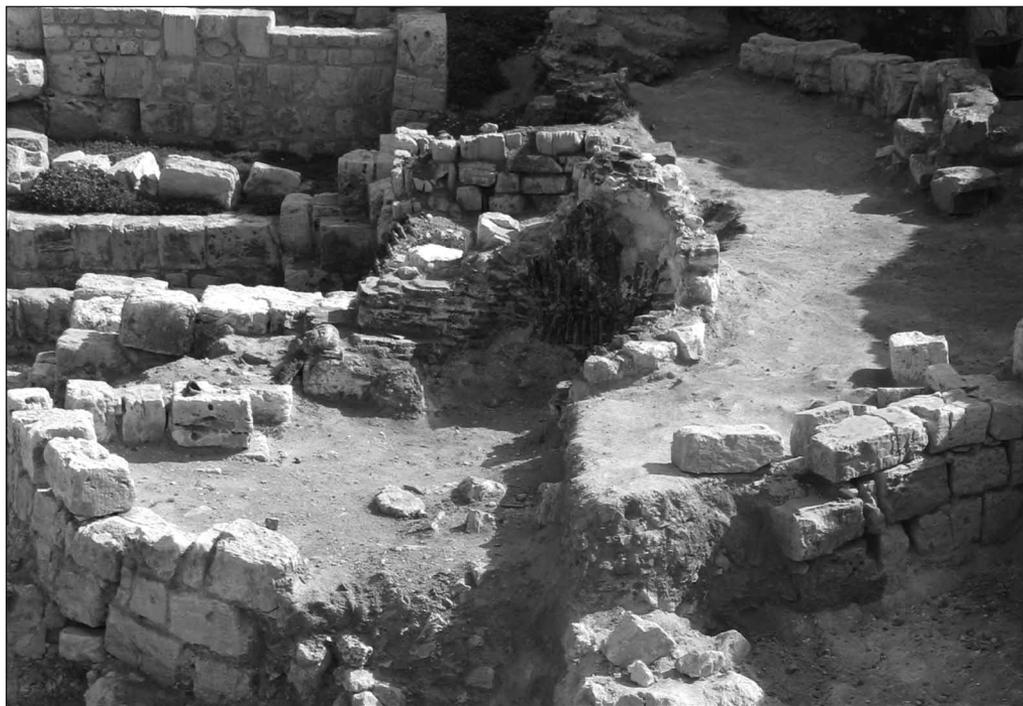
Immediately below the deposits of ashes intermixed with rubble resulting from subsequent rebuildings of the bath, excavators cleared a partly preserved lime kiln. The structure, located in the southeastern corner of the trench, featured a circular (c. 1.00–1.10 m in diameter) updraft kiln built of red bricks set in clay mortar [Fig. 6]. The vaulted entrance to the furnace chamber had been discovered already in 1999, next to an almost identical

Fig. 6. Kiln discovered below the layers of ash in Area F, view from the west (Photo G. Majcherek)

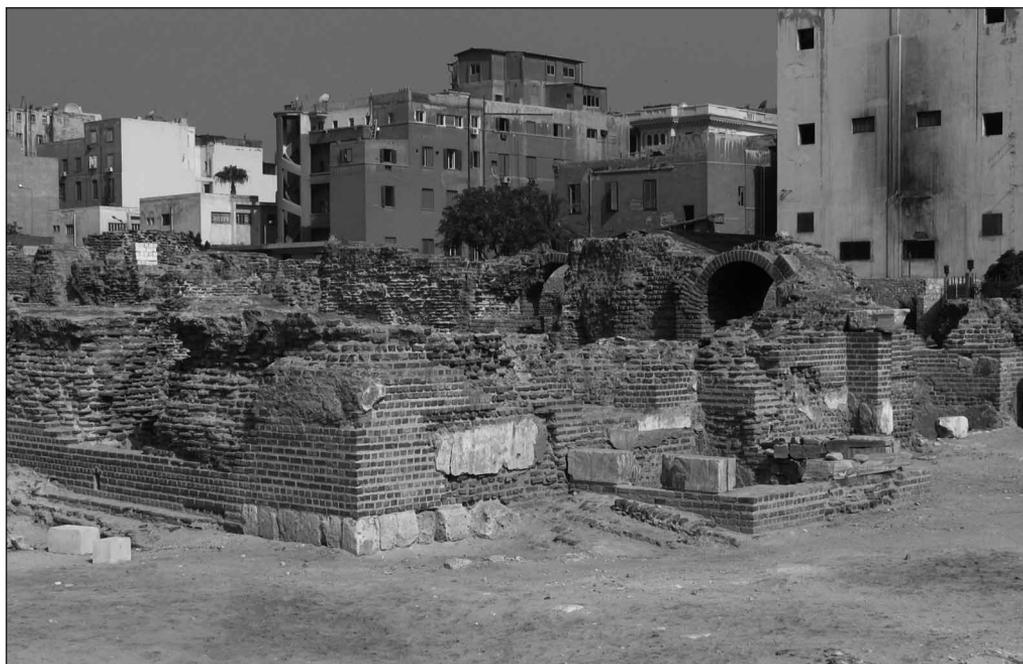
The deterioration of most of the wall facing was substantial with serious loss of mortar from the joints. The most acute problem faced during the restoration operation was a lack of new bricks of proper specification and adequate quality. The use of original bricks retrieved from the excavations effectively alleviated this problem. The entire facing, up to 2.50 m

Fig. 12. East façade of the Late Roman Bath after conservation, view from the southeast (Photo G. Majcherek)

high in places, was restored with re-laid bricks. Deteriorated mortar joints were cleaned and re-pointed, and the brickwork stabilized as a whole. The principle of preserving original wall bonding, as well as minimal intervention, was strictly observed. In some extant areas belonging to the original phase of the building and structured in flat Roman bricks, new bricks cut to appropriate dimensions and matching original ones were used in order to preserve the historical substance [Fig. 12]. As a rule, only lime-sand mortar was used in the bonding.

A similar conservation operation was conducted on a 12-m long stretch of the southern elevation. The wall facing here, including much deteriorated and detached brickwork, was thoroughly restored [cf. Fig. 12]. The operation also included the restoration of an almost totally destroyed semicircular pool in the dextritorium. Additional repairs were made on the hypocaust system in both the tepidarium and the dextritorium. Some seriously deteriorated square *pilae* once supporting the hypocaust, initially secured

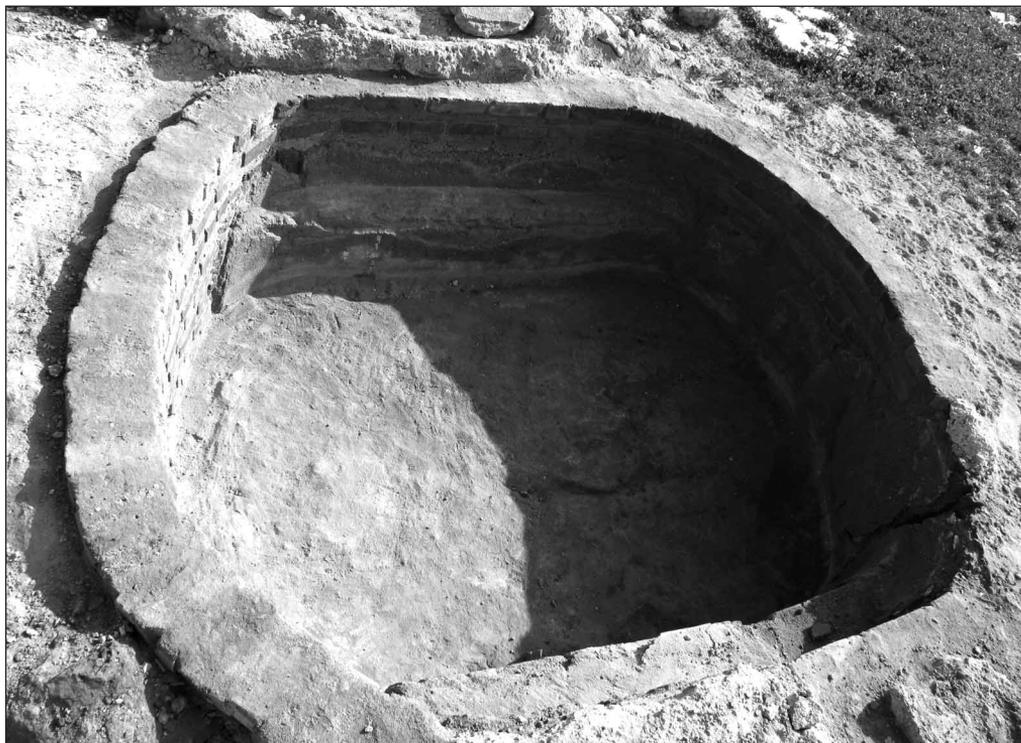
Fig. 13. *Oval frigidarium pool, after conservation, view from the north*
(Photo G. Majcherek)

Yet another frigidarium pool, of oval shape, was also restored⁵ with original bricks found nearby (Rodziewicz 1979) [Fig. 13]. The same procedure was applied to a nearby manhole which leads to the underground drainage system. Its walls were repaired with bricks and a new head, slightly elevated with regard to the surrounding ground, was built. The manhole was secured with a wooden grate.

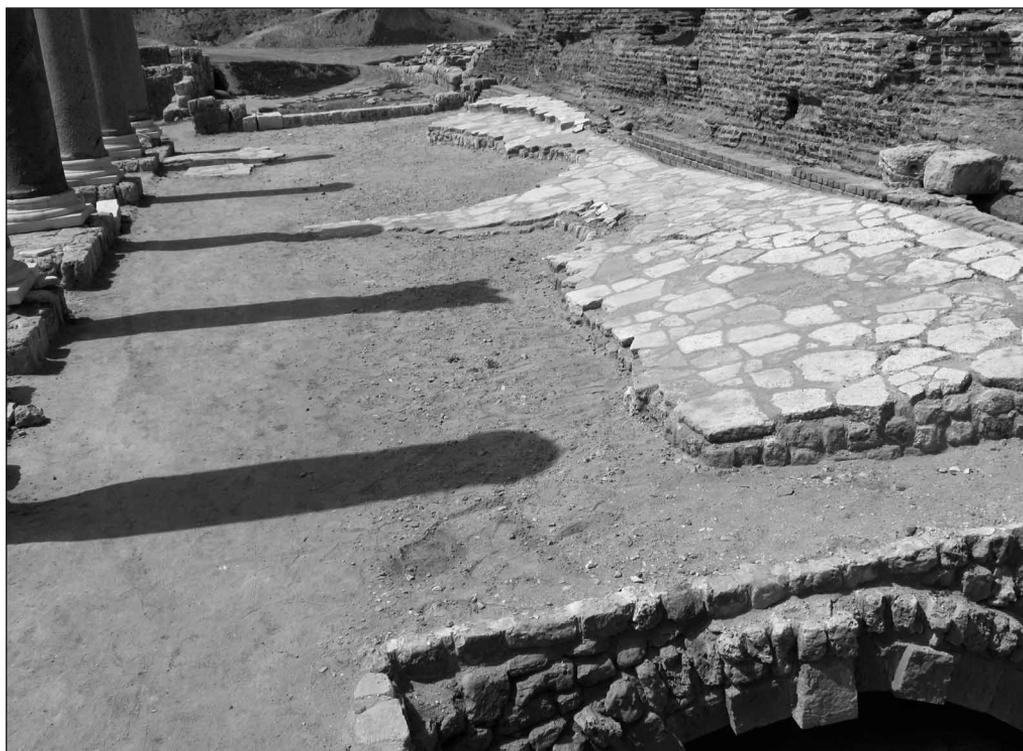
Fig. 14. South façade of the bath and adjoining passage, after conservation, view from the east (Photo G. Majcherek)

The conservation of an extant pavement in the southern passage of the bath proved to be a major operation. The pavement,

made of irregular nummulithic limestone slabs, had survived in several separate sections located mostly next to the channel running along the façade. The flagging has subsided considerably in places, most probably due to seismic activity. Whole sections of flagging were now set in a new mortar bedding and consolidated [Fig. 14]. The edges of the flagging were additionally reinforced with a supporting band of lime-sand mortar. The gaps in the flagging will be filled eventually with gravel.

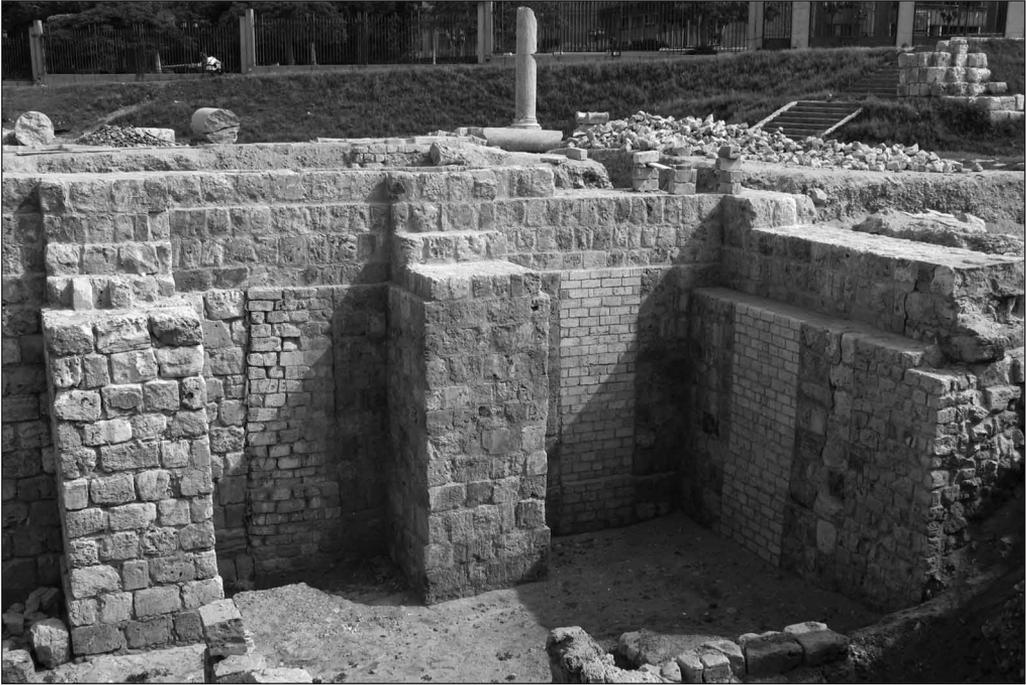
*Fig. 15. Outer wall of the bath, after conservation, view from the south
(Photo G. Majcherek)*

of large masonry blocks at regular intervals, the intervening sections built in *opus caementicium* with limestone facing enclosing a rubble core. The pillars were almost totally gone, while extant screening walls were in very poor condition.

The latter were treated first. The core of the wall was consolidated and the masonry facing restored wherever necessary. In 2006, this huge wall (c. 1.55 m wide) was rebuilt to a height of some 1.60 m above ground level (Majcherek 2009: 38 and Fig. 9). This restoration was completed this season. The rebuilt section of the wall now reaches a height of some 4 m [Fig. 15].
