KOM EL-DIKKA

EXCAVATION AND PRESERVATION WORK, 2005/2006

Grzegorz Majcherek

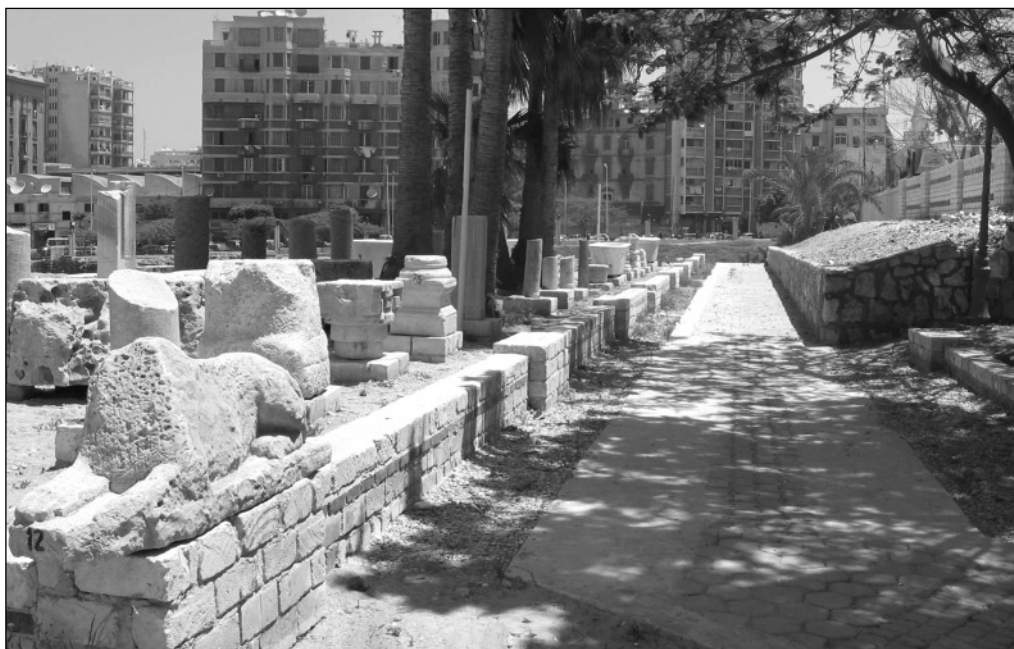
*Fig. 1. Path leading to the Villa of the Birds, current view
(Photo G. Majcherek)*

was thoroughly rearranged and a similar display of architectural pieces (columns, bases, capitals and fragments of statuary), coming from various sites in Alexandria and in temporary storage at Kom el-Dikka, was mounted along the footpath leading to the Villa of the Birds. The path itself, made in this stretch of salvaged basalt setts, was widened here to c. 3 m [*Fig. 1*]. The steps leading down to the Villa from the level of the cistern (Kołataj 1997: 22 and *Fig. 3*) were also similarly upgraded.

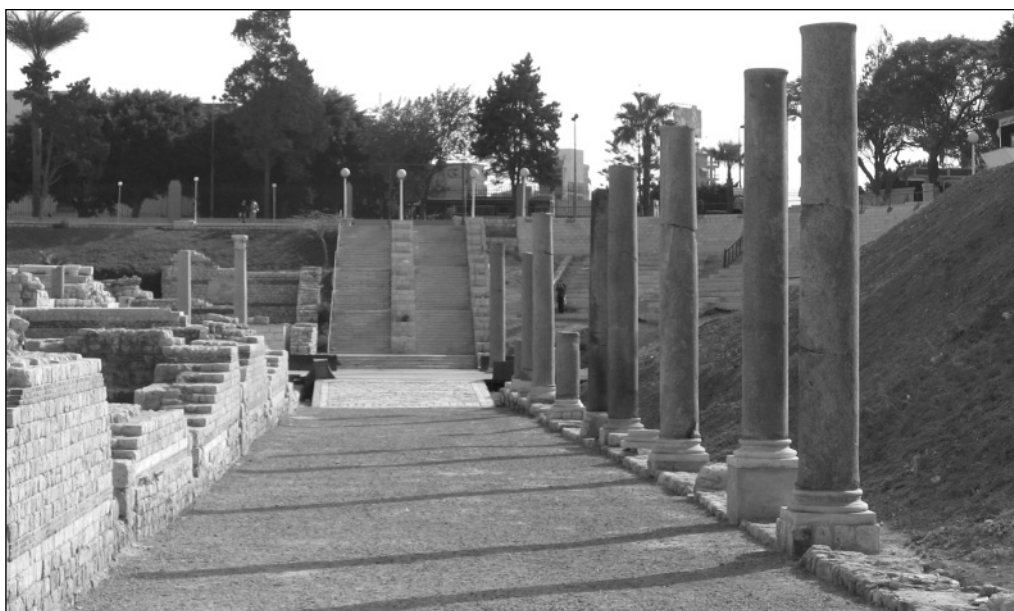
*Fig. 2. Restored portico, looking south
(Photo G. Majcherek)*

The most challenging operation of the season was the landscaping of the western part of the site. The entire excavated and restored section of the portico (some 70 m long) was leveled and scattered with gravel [*Fig. 2*]. A stone ramp was introduced to facilitate communication between the modern auditorium and the portico. The western edge of the excavation area was formed into a sloping escarpment and grassed. A new access road to the excavated part of the site was arranged.

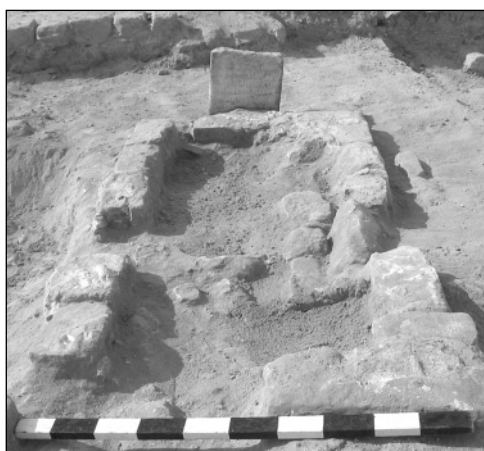
Fig. 3. Middle Necropolis Grave in Area CW (Photo G. Majcherek)

Graves of the so-called Middle Necropolis phase were cleared directly below the Upper Necropolis level. Despite serious damages caused by the digging of later internments, a few of the graves turned out to be in surprisingly good condition. The aboveground superstructures of these earlier tombs were usually built of larger blocks, forming rectangular structures [Fig. 3]. Floors were covered with a thin layer of pebbles as a rule. Interestingly enough, in several cases funerary stelae were found where they had been immured.

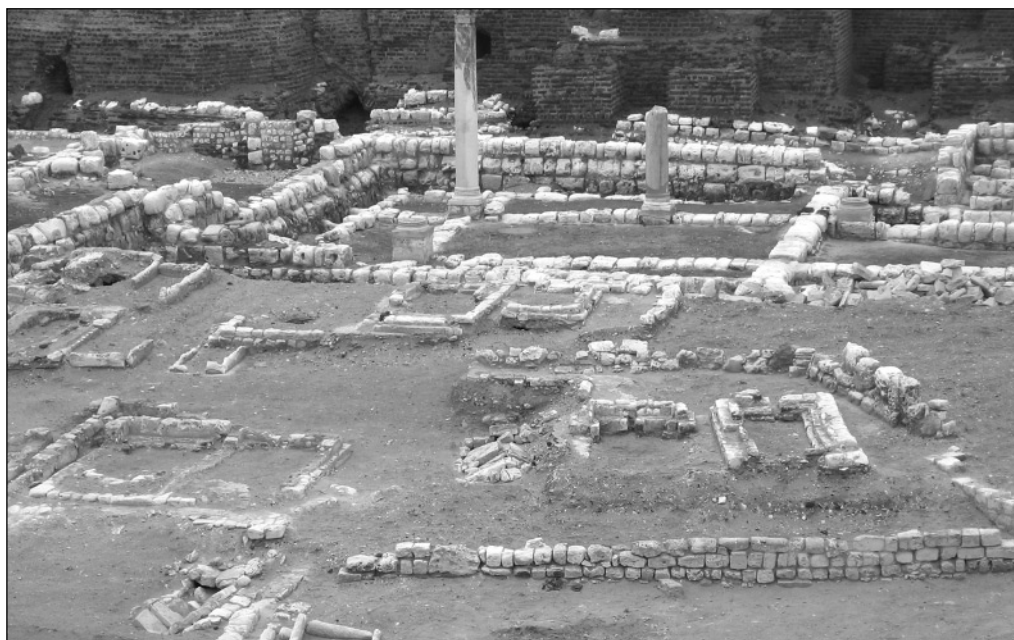
Fig. 4. Area CW. Moslem burial ground, seen at the beginning of the season (Photo G. Majcherek)

Excavations started with the exploration of medieval Moslem graves CW 1 – CW 39, identified in this area during the previous season [*Fig. 4*] (Majcherek 2006: 25; for excavations in the adjacent area AS, cf. Majcherek 2004: 32-34; see also contribution by E. Kulicka, below in this volume). On-site anthropological examination was carried out by Robert Mahler from the PCMA.

In this part of the burial ground, the graves were packed in tightly. At least two separate clusters, each enclosed within a perimeter wall, were identified: graves CW 17-19 in the southern part of the area

and graves CW 24-26 lying further to the north. In both cases, the perimeter walls were structured of rather small stones set in lime mortar and preserved generally to a height of 0.20-0.40 m, although one section was even 0.90 m high. Of special interest was the southern perimeter wall (nos 20-21) preserving a small *mibrab* niche lined with plaster. Similar architectural features had been recorded previously in other areas of the cemetery as well (Promińska 1972: Plan II; cf. also Majcherek 1999: 34).

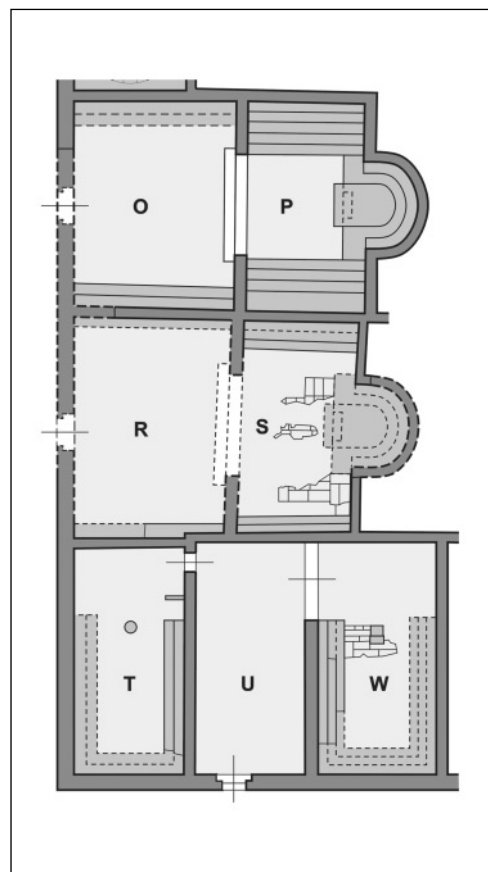
Fig. 5. *Late Roman auditoria*
(Plan A. Pisarzewski)

Fieldwork in recent seasons had brought the discovery of a large and well-preserved complex of lecture halls (auditoria) of Late Roman date. So far, 17 auditoria situated along the Theater Portico have been identified and explored (Majcherek 2004: 27-32; 2005: 19-22; 2007: 25-28). Since there was every reason to believe that similar halls lined the entire length of the portico, further structures of the kind were anticipated in the yet unexplored Area CW. This was indeed the case with three more halls (RS, T and W) being cleared here this year [Fig. 5].

Hall S, uncovered further to the north, turned out to be completely different in plan and orientation [*Figs 5, 7*]. It was much larger, forming together with its vestibule (R) a rectangle 12 by 19 m. Aligned E-W, it had an apse projecting eastward, beyond the rectangular outline of the room. The walls of the apse have not survived above the foundations, but sufficiently however for a full graphic reconstruction including semicircular benches (preserved in the northern part), clearly in imitation of a *synthronos*. The regular benches along the walls were replaced in this case with an asymmetrical pair of stands on opposite walls, three rows on the north wall, but only two on the south one.

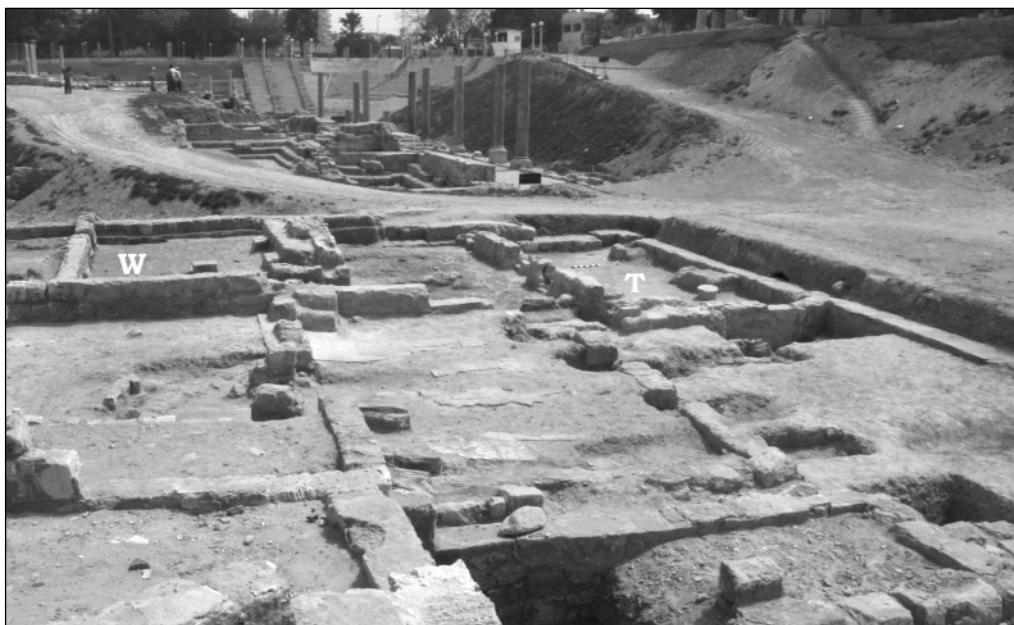
*Fig. 6. Late Roman auditoria T and W, looking south
(Photo W. Jerke)*

Hall T (c. 9.00 by 4.70 m) featured a standard arrangement with two rows of benches running around three of the walls [Fig. 6]. The southern section with the dais has been preserved only as an imprint on the ground. An upturned marble base found close to the northern end of the benches may have served as a small pedestal, set in the middle of the room in a manner similar to the pedestals

Auditorium W followed the same design. Likewise oriented N-S, it had three rows of benches along the walls (only the western run has been preserved) [cf. *Fig. 7*]. In its northern part, a low pedestal made of a large block of nummulithic limestone was found *in situ*. It has a small rectangular hollow evidently serving to mount some additional furnishing. The only viable entrance to this hall, which had its back to the bath passage, was from the vestibule in unit U which had a doorway opening onto the passage. In a later phase, auditorium T was also entered from this vestibule.

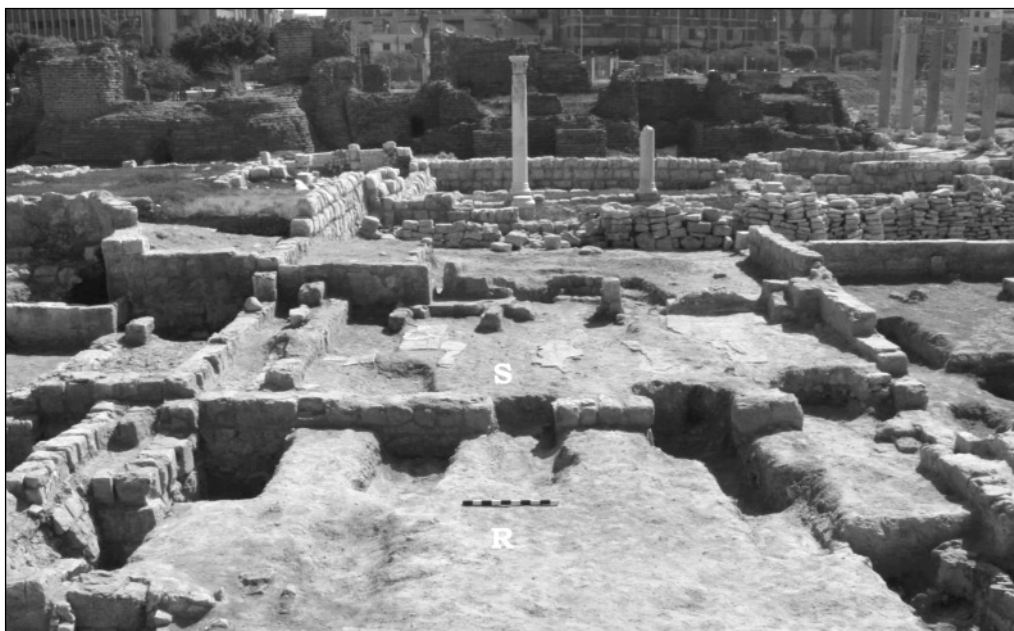
*Fig. 7. Auditorium S with vestibule R in front, looking east
(Photo W. Jerke)*

a much bigger unit (R) to the west of it and directly adjacent to the back wall of the portico. Indeed, it seems that instead of a solid wall with a doorway leading through it into Hall S, we should rather envision low lateral walls screening the sides of the benches but not hampering a view of the apse. This vestibule was furnished with a single-step bench of stone blocks lining the opposite walls on the north and south (where some remnants were recorded). It appears to have been entered from the portico.

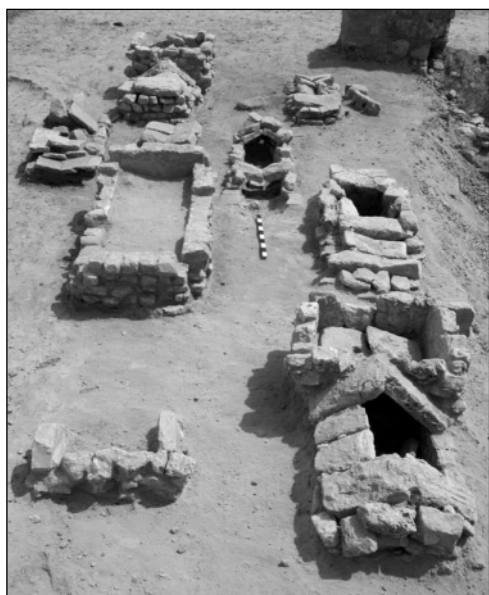
*Fig. 8. Upper Necropolis graves in Area L
(Photo W. Jerke)*

A fragment of the medieval Moslem cemetery overlying the southwestern part of the cistern (for explorations of this part of the site, cf. Kubiak 1967: 75-77, Pl. II) was explored, uncovering graves of the Upper Necropolis immediately below the present topsoil (c. 16.90-17.00 m a.s.l.). Graves were clustered in the middle of the excavated area [*Fig. 8*], the ones at the south and west edges apparently destroyed by modern construction works in the 1960s. The tombs were oriented SW-NE, in keeping with traditional Islamic funerary practice, the head of the deceased placed in the direction of the *qibla*. Altogether 12 graves (L 1-L 12) were excavated, representing two basic types of construction already identified in other areas of the cemetery.

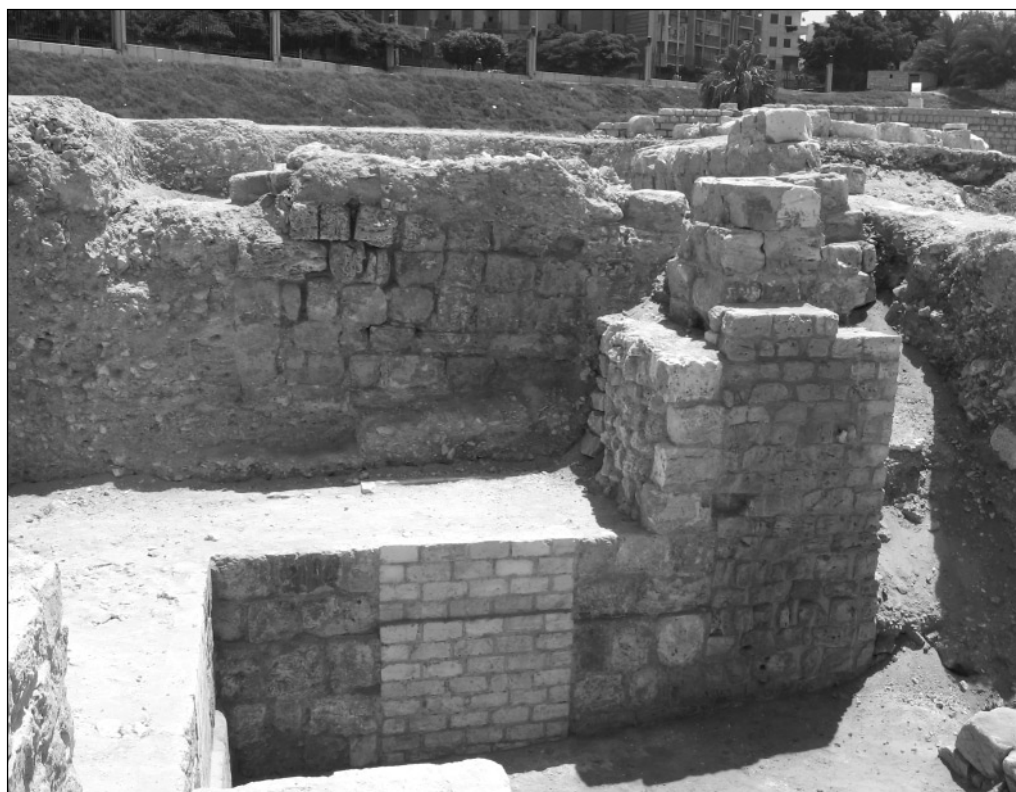
*Fig. 9. Outer wall of the bath complex, after partial restoration
(Photo G. Majcherek)*

A major restoration operation was conducted in Area F, where a large section of the huge outer wall of the bath was rebuilt [Fig. 9]. Prior to that, the wall was tested archaeologically down to the original footing at c. 1.40 m below the floor level of nearby Early Roman house F. The wall disappeared apparently in the Middle Ages, dismantled in a large-scale robbing operation. The original pillar structure composed of pillars made of large masonry blocks and intervening sections built in *opus caementicium* with limestone facing enclosing a rubble core (c. 1.60 m

wide) was robbed out in a characteristic manner, already evidenced at the site: little if anything remained of the pillars, while the extant screening walls were in very poor condition. These were treated first, consolidating the core of the wall and restoring the masonry facing wherever necessary. The rebuilding operation entailed also some protective dismantling of adjacent extant parts in order to deal with dangerously overhanging blocks. The dismantled wall sections were duly marked and stored for reassembly once the rebuilding has been completed.

The new wall footing was made structurally sound and the whole wall was rebuilt to about 1.60 m above the floor level of the adjacent Early Roman villa. The operation will be continued next season when the wall is planned to be restored to a final height of close to 5 m.

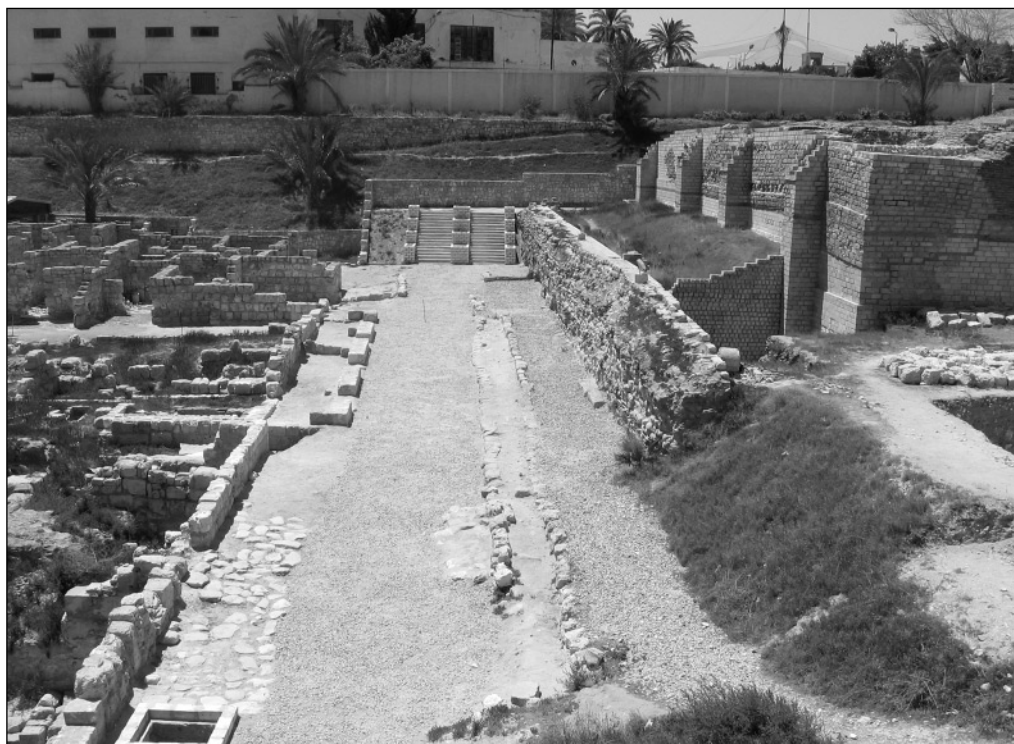
Fig. 10. Street R4 after conservation in 2006
(Photo G. Majcherek)

Street R4 and the adjoining domestic quarter is planned as an essential part of the future Archaeological Park. The idea is to present the multiphase character of the area with its various structures covering a wide span from the Early Roman to the Byzantine age. The street itself, giving also access to the Villa of the Birds housing Roman mosaics, will constitute a major part of the visitors itinerary. The 2006 operation entailed not only landscaping, but also substantial conservation work [Fig. 10].

The street elevation for a stretch of some 40 m was treated. Badly eroded stones were replaced with new ones, missing joints restored and the whole structure thoroughly consolidated. A considerable section of the wall enclosing rooms G 2-3, originally structured in the pillar technique like many other features of the period, was restored to a height of some 1.10 m in order to comply visually with other extant walls. Next, the row of antique shops uncovered in front of House G was partially restored. The shops had been found almost entirely dismantled, save for small sections of the walls in the southern part (Majcherek 2000: 37-38). Only one course of the original masonry was restored, however, in an effort to retain the balance between restored and original fabric.

The whole run of the street was cleared and the Late Roman surface exposed. A deep manhole used to service the ancient sewage system in the street was consolidated and partly restored. The head was built in new stone masonry, protruding c. 0.30 m above the ground level and secured with a wooden cover to avoid any hazards. The whole run of the street was then covered with a gravel layer c. 0.10 m thick. In order to cope with the increasing number of visitors, a modern staircase previously built at the southern end of the street (Kołataj 1999: 24 and Fig. 11), was substantially expanded. Two more runs of steps were added and the whole width enlarged to about 6 m.
