EARLIER RESEARCH

Clarifying variations in the shape of the structures of a temple, in which so many different teams and archaeologists have worked, is a difficult and oftentimes controversial task. The present article examines the progress made in the Upper Courtyard, which is a particularly complex part of the temple. It begins with an

expounding of the main contributions to the study of the issue and the evidence upon which they were based, followed by a preliminary analysis of the archaeological results of seasons 2014 to 2016, which have suggested new directions for further investigation.²

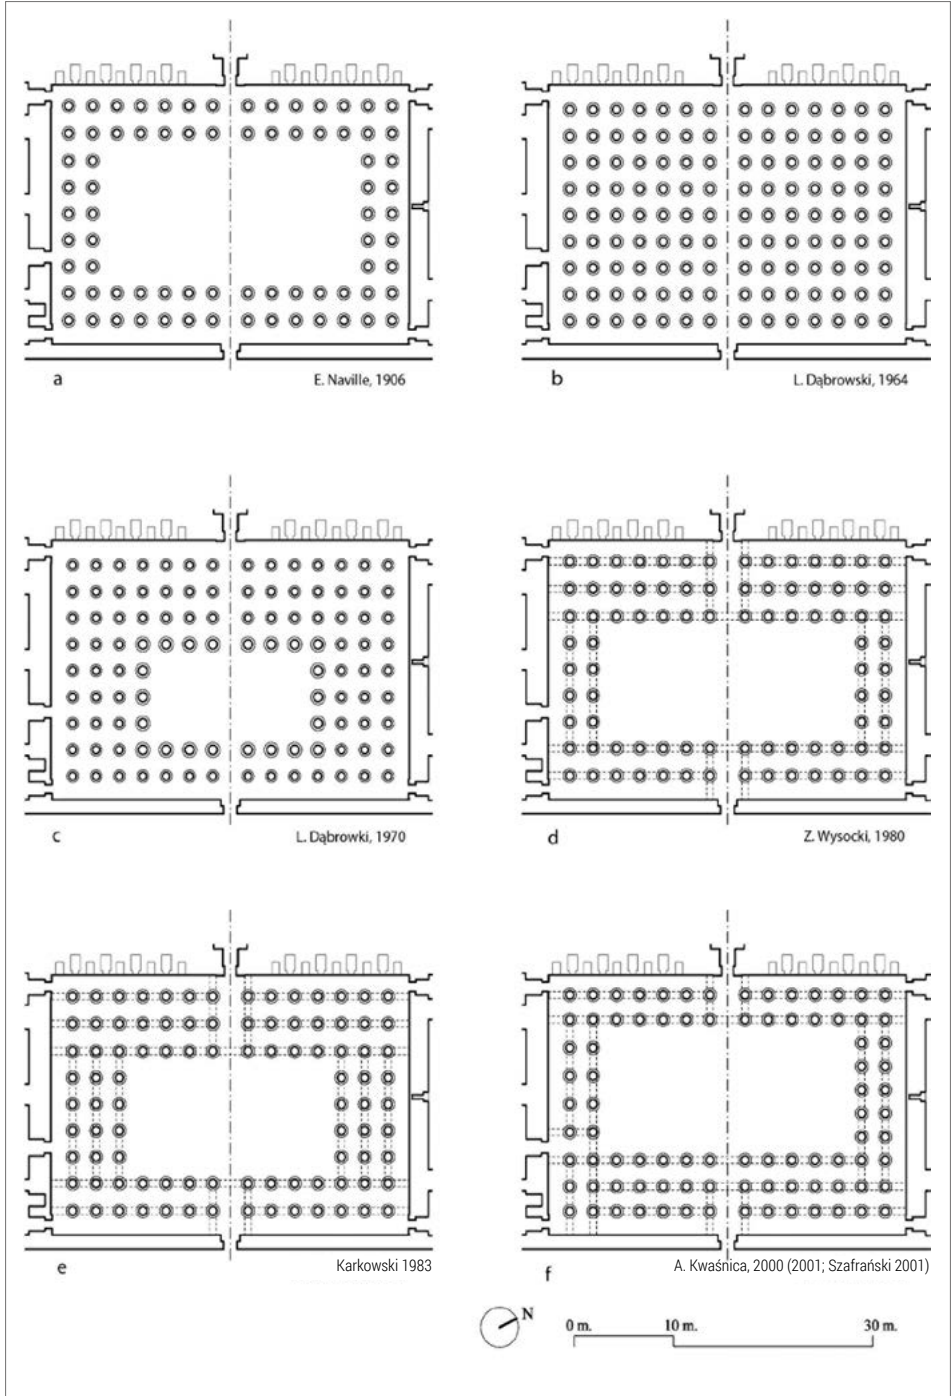
Fig. 1. The original configuration of the Upper Courtyard of the Temple of Hatshepsut according to different researchers (Drawing S. Alarcón Robledo)

ence of an open space at the center of the hypostyle hall [Fig. 1:c]. Apart from the symmetry of the outlined structure, the coexistence of two architectural orders should be noted in this second proposal. Dąbrowski suggested that the uncovered central part of the courtyard was bordered by 22 columns of a larger size (Dąbrowski 1970). Should that have been the case, it would have been unprecedented, although sparking an evolution of the design in the adjacent temple of Tuthmosis III, where the central part of the hypostyle hall was covered by a higher roof, supported by larger columns. The increased roof height opened the possibility of natural light streaming into the hall through windows opened between the two roofs. From an architectural point of view, this structural solution constituted an important step forward; one which could have influenced later architecture, as attested by similar spatial configurations in later New Kingdom constructions, such as the great hypostyle hall at Karnak and the halls of the Ramesseum and the temple at Medinet Habu (Karkowski 1983: 147, note 22). Given these architectural parallels, this configuration would have been plausible, but further research led to its rejection.

The architect Zygmunt Wysocki continued Dąbrowski's investigations of the original configuration of the colonnade of the Upper Courtyard, ultimately rejecting his revolutionary ideas (Wysocki 1973: 257; 1980: 59). Upon reexamination of the column bases, shafts and decoration, Wysocki concluded that the small number of fragments of the smaller columns (Wysocki 1980: 56) and the supporting points on the architraves could be interpreted only if all of the columns originally set in this courtyard were of the same size. The restitution of these resulted in a total height of 4.945 m from the top surface of the base to the underside of the architraves. Regarding the smaller columns, it is likely that they did not belong to this part of the temple, or if they did, they would have been set in a characteristic place, upon a platform or plinth that would increase their height sufficiently to reach the architraves (Wysocki 1980: 69; Karkowski 1983: 145). Consequently, Wysocki proposed a new plan of the courtyard (Wysocki 1980: Fig. 9) with two rows of columns on the northern, southern and eastern sides, and three rows in the west [Fig. 1:d].

courtyard with three rows of columns to the north, south and west of the courtyard, and two rows on the east (Karkowski 1983) [Fig. 1:c]. His ideas were grounded

One piece of evidence on which he based his conclusions was an architrave with a preserved minimal length of 2.75 m (Kwaśnica 2001: 92).³ This led Kwaśnica to assert that the distance between the columns ought to have been longer somewhere in the courtyard, which would not be surprising, considering that it was a common solution when enlarging walkways through colonnades. There are two examples of this practice in the courtyard, where the columns flanking the main axis of the temple allow for a wider path into the courtyard and the Amun Sanctuary. Kwaśnica suggested a similar design for the walkway to the entrance of the Royal Cult Complex located on the southern side of the Upper Terrace. The points where the architraves were set upon the south wall indicate that the arrangement was similar to that of the above-mentioned walkways, breaking the continuity of the architraves rows, and turning them towards the doorway [Fig. 1:f].

and west of the courtyard, and three of them to the east, the third of which would have been added at a later stage of the construction process [Fig. 1:f]. The asymmetry of the plan, which derives from the elongation of the columns' distance on the pathway to the Royal Cult Complex, is particularly remarkable. Thus, the northern side of the courtyard would have originally been composed of 10 columns, whereas the southern one would have had nine. Kwaśnica was aware of the atypical character of this unprecedented configuration; he argued it based on the complexity of the temple, the modifications that it underwent during the original construction,⁴ and the compositional issues that its builders had to face (Kwaśnica 2001: 97).

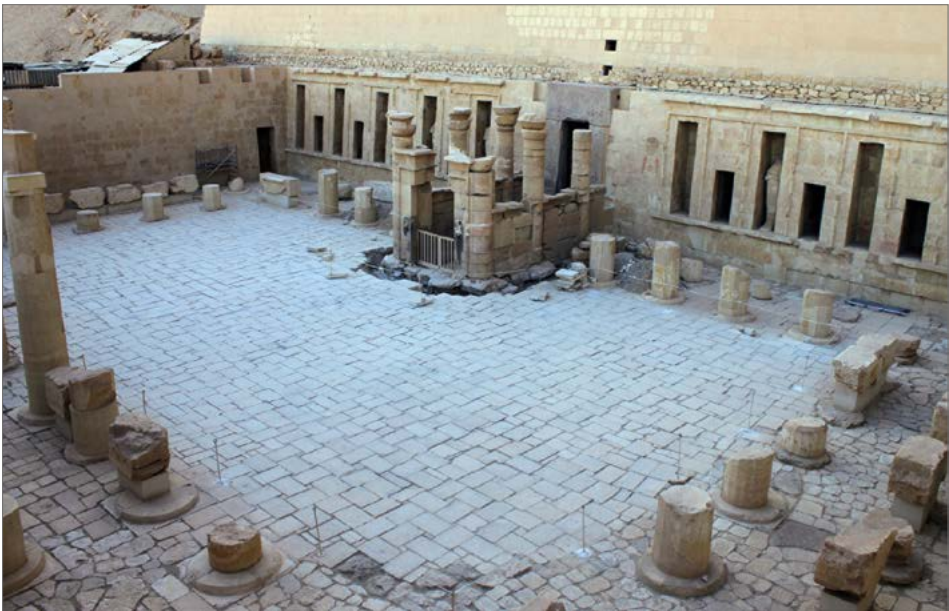
Fig. 2. General view of the Upper Courtyard of the temple, during the excavations of the foundations of the Ptolemaic Portico (S1/14) (PCMA UW Deir el-Bahari Temple of Hatshepsut Project/ photo D. Wiczorek, 2014)

One of the main reasons why Wysocki proposed three rows of columns on the west side of the courtyard as opposed to the east side [see *Fig. 1:d*] was the assumption that the bases upon which the Ptolemaic Portico stood [*Fig. 2*] had not been moved since the initial construction took place and that the Ptolemaic builders followed the extant disposition of columns while setting it up (Wysocki 1980: 69). Agreeing with Naville's idea, Kwasnica wrote: "... The Ptolemaic architects had indeed used the extant column bases to set up their columns, but only the first four counting from the Sanctuary. They added two more on the east, as indicated by the level of the tops of these bases, which is in both cases 6 cm above that of the other four resting *in situ*. The ancient Egyptians could not have allowed such a bump to appear right in front of the entrance to the Sanctuary" (Kwaśnica 2001: 89). He also stated that "... no attention was paid to leveling the ground under these two new bases" (Kwaśnica 2001: 90).

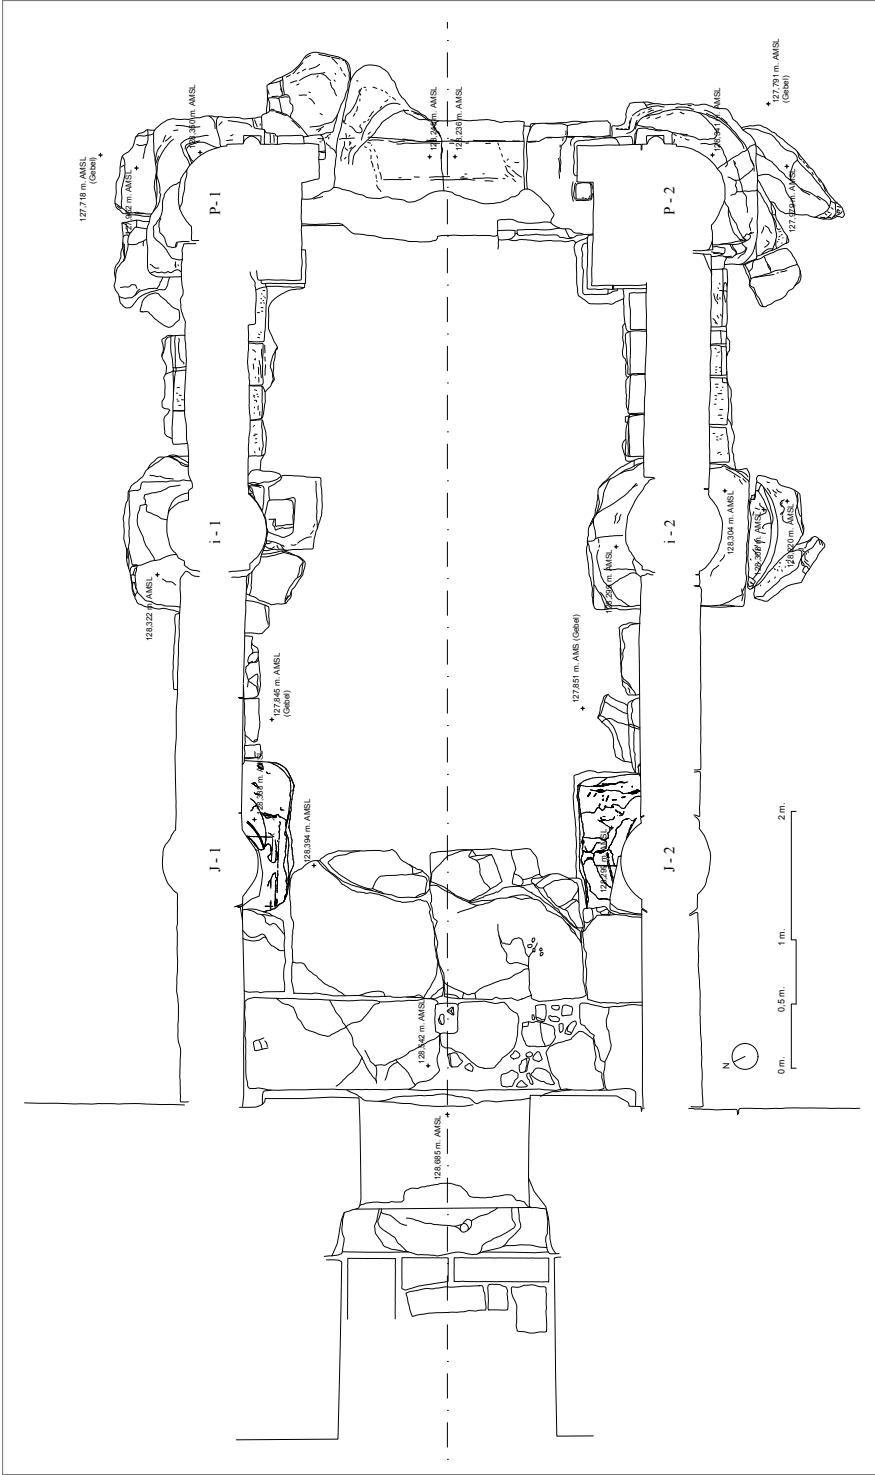
Fig. 3. Trench S1/14: plan showing the Ptolemaic Portico with the foundations uncovered (PCMA UW Deir el-Bahari Temple of Hatshepsut Project/ drawing S. Alarcón Robledo)

served between the heights of bases J-1/i-2 and J-2/i-2 [*Fig. 3*]. The subsoil of these bases (trench S1/14) was uncovered in search of evidence for the two easternmost bases being added by the Ptolemaic builders. Otherwise, the results would confirm that they were still in their original positions, as Wysocki believed.

A piece of diorite was found embedded in the trench section between bases i-2 and P-2 [see Fig. 3]. Diorite is a highly tough rock which was often used for working red granite. The most plausible hypothesis is that this fragment splintered off from a tool used on the surface of the doorjamb or lintel of either the entrance to the Amun Sanctuary or the doorway that enters the courtyard from the Upper Portico. This also suggests that the red granite brought to the site was not fully dressed, as was the case of softer stones. In either case, these stone elements were incorporated into the temple in the times of Hatshepsut, and considering that there is no evidence of any

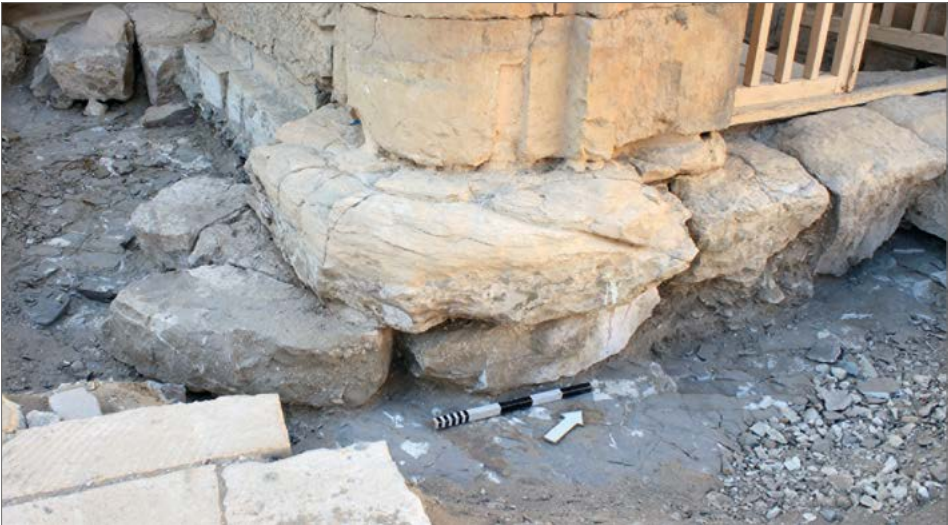
Fig. 4. Trench S1/14: view of the uncovered foundations under column base P-1 (PCMA UW Deir el-Bahari Temple of Hatshepsut Project/photo D. Wieczorek, 2014)

Contrary to Kwaśnica's ideas, the excavations revealed that the bases were carefully set on foundation blocks, designed to transfer their structural load to the bedrock [*Fig. 4*]. Such foundation blocks had been attested earlier, for instance, in the excavation of the substructure of the south wall of the courtyard (Stefanowicz 1991; Szafrąński 1995). The blocks found underneath bases P-1 and P-2 have the necessary thickness allowing for the upper surface of the bases to be set at the proper height of the courtyard pavement, which suggests that the setting of the bases and of the foundations was most likely part of the same architectural undertaking. This is even more apparent when we consider that not all the base blocks in the courtyard have the same thickness. According to Kwaśnica, the two eastern bases of the portico were added in Ptolemaic times (Kwaśnica 2001: 89); had that been the case, the foundations would have been placed there at the same time. The ques-

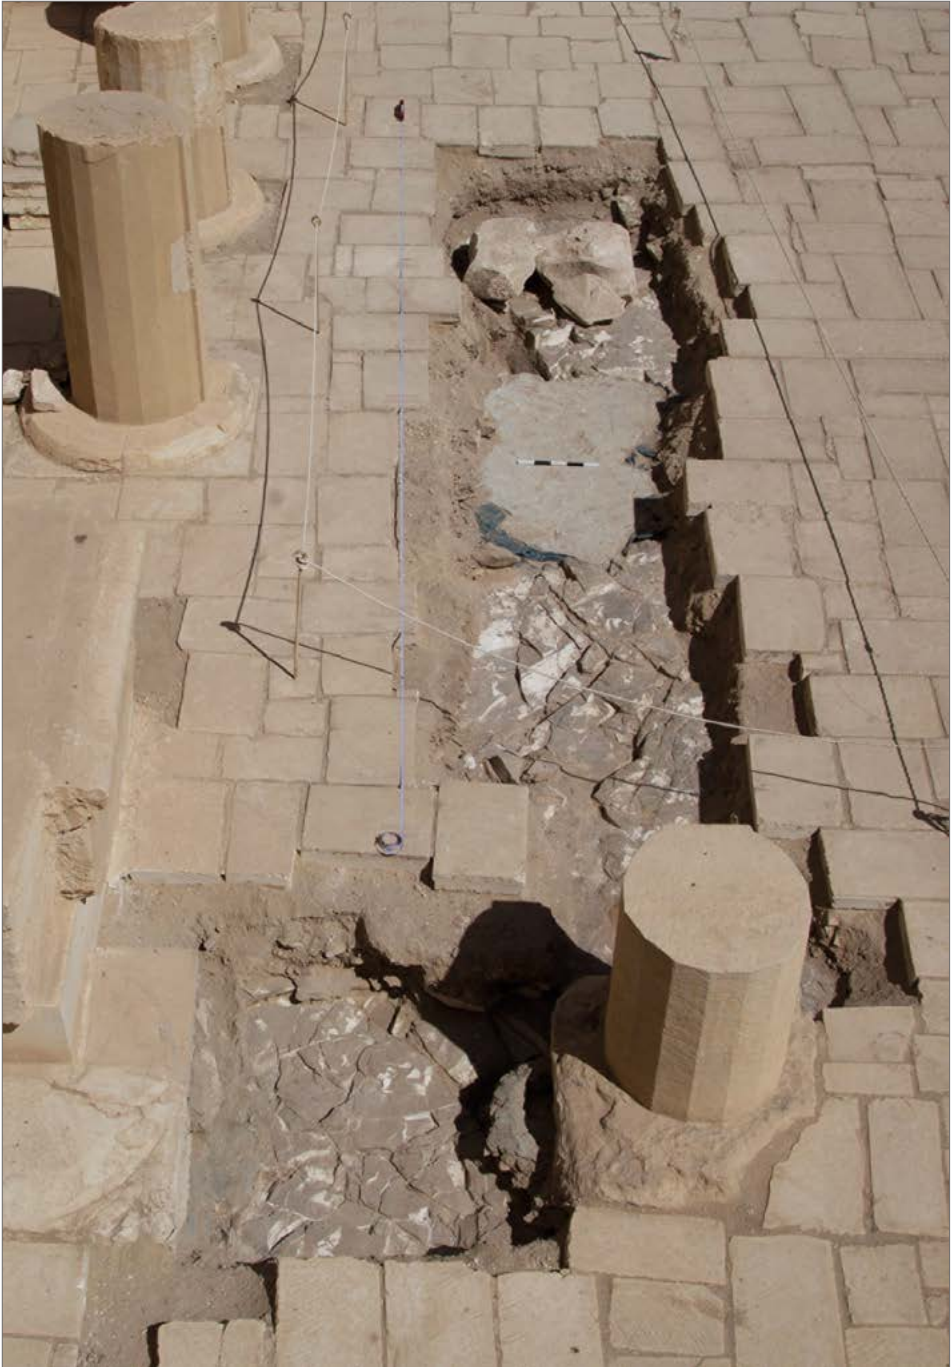
Fig. 5. General view of trench S1/15, excavated in 2015 (PCMA UW Deir el-Bahari Temple of Hatshepsut Project/photo M. Jawornicki, 2015)

The space between bases i-12 and IV-12 was also excavated in the hope of finding foundations for comparison with those of the Ptolemaic Portico. The bases were thick enough to reach bedrock without the need for foundation blocks. Furthermore, cement was found under both of them, proving that their substructures had been modified in modern times [see Figs 5, 6].

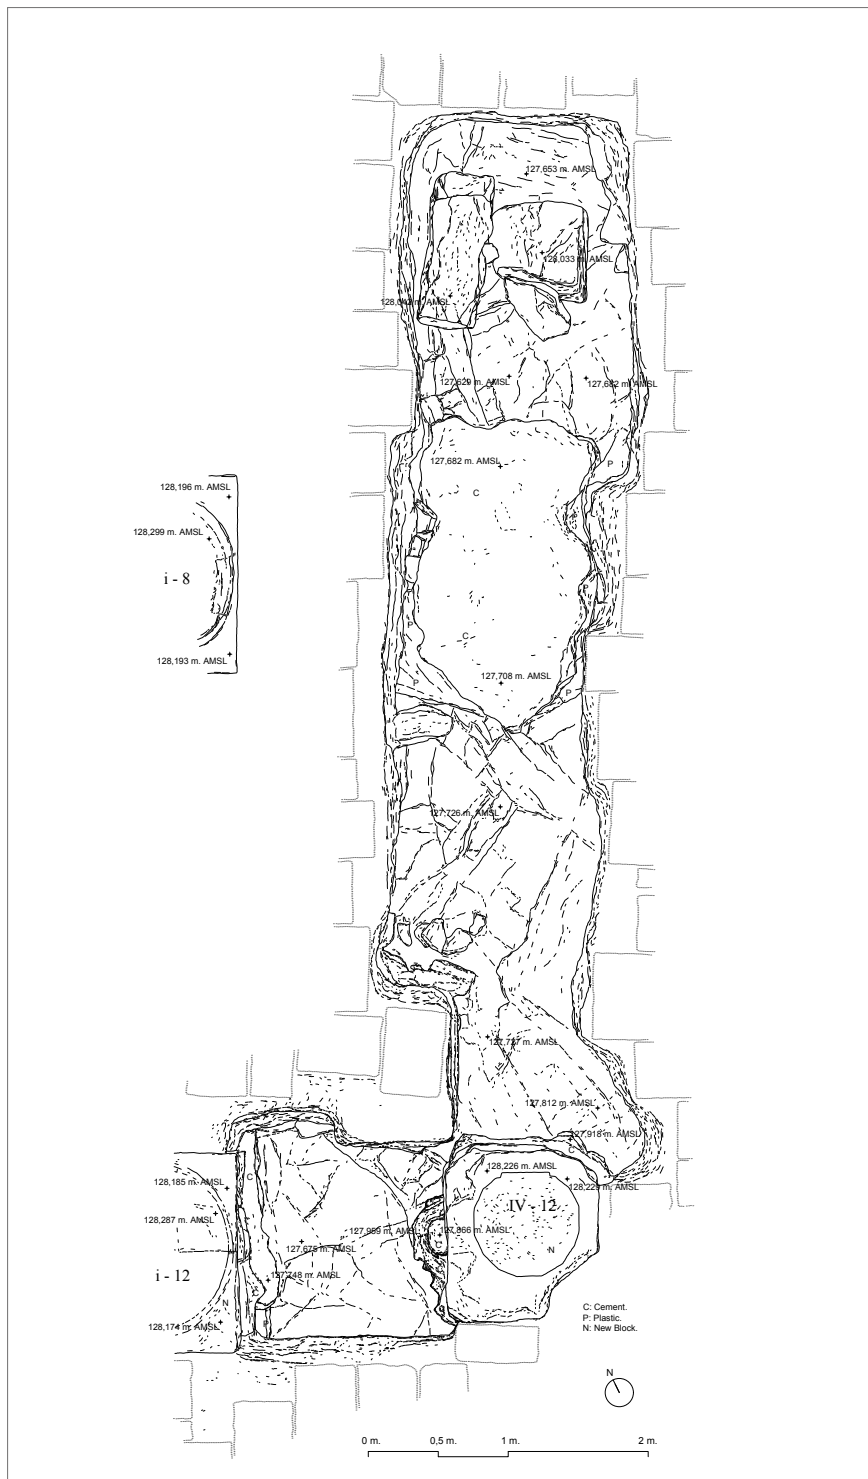
Fig. 6. Plan of trench S1/15, showing cement and plastic present in some parts of the excavated area (PCMA UW Deir el-Bahari Temple of Hatshepsut Project/drawing S. Alarcón Robledo)

be *in situ*. The trench corresponded to the southern half of the alleged third row of columns. Cement and modern plastic found over a considerable part of the bedrock surface in the trench proved that the place had already been excavated down to bedrock, leaving no evidence of value for the issue at hand. A few roughly worked blocks were found to the north of the cement [Figs 5, 6], but the mixed material and the inconsistency of the layers among the blocks made it apparent that they had been removed from their original setting.
