# KOM EL-DIKKA

## PRESERVATION WORK, 1999/2000

Wojciech Kołataj

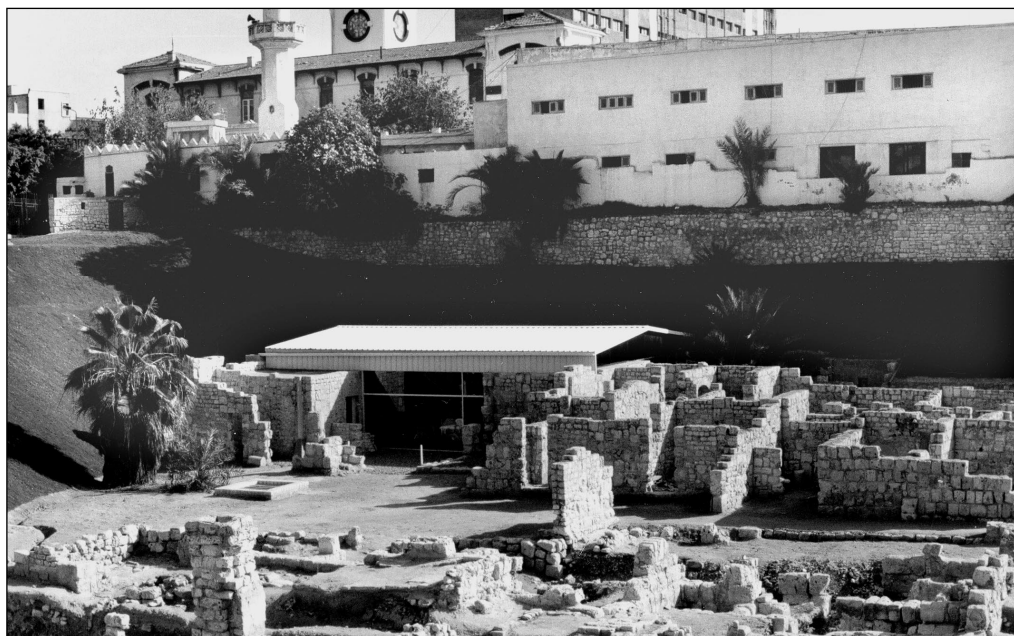
*Fig. 1. Slope along the southern border of the area  
(Photo W. Kolqtaj)*

*The conservation mission<sup>1)</sup> was obliged to carry out landscaping work on 350 m of slope along the eastern and southern border of the concession area, including retaining walls for the deeper archaeological trial pits (Figs. 1, 2). Alexandria Governor Mohammed Abdel Salam el-Mahgub granted the necessary funds to have these slopes covered with grass. A water supply pipe was installed all along the escarpment.*

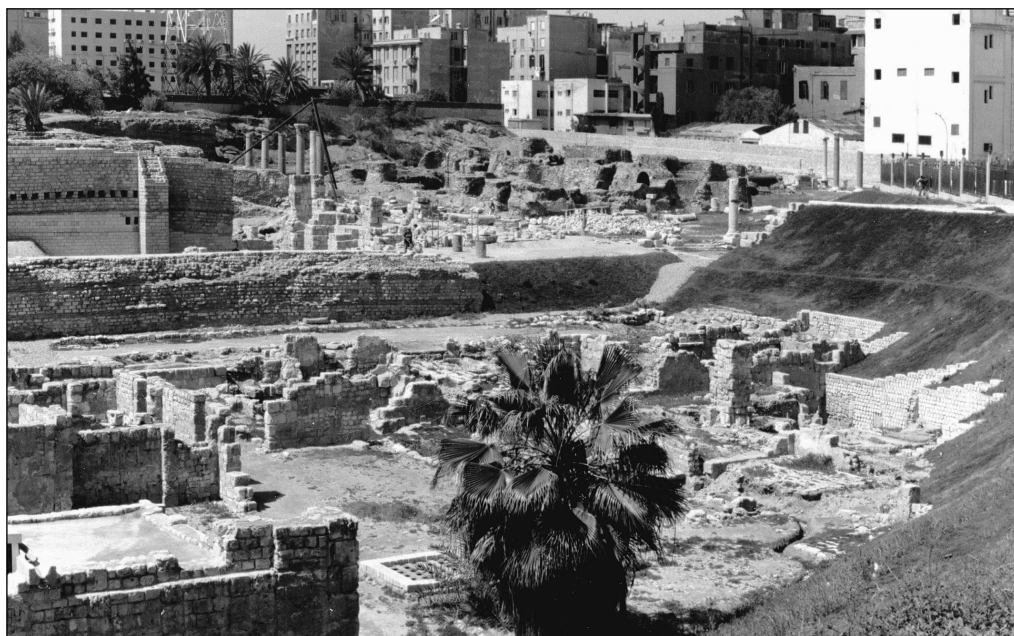
*Fig. 2. Slope along the eastern border of the area  
(Photo W. Kolqtaj)*
